WATERSHED SURVEY RESULTS MEMORANDUM

TO: Town of Sutton, NH and Kezar Lake Protective Association
FROM: Lori Kennedy, Horsley Witten Group and Christine Bunyon, FB Environmental Associates
SUBJECT: Kezar Lake Watershed Survey Results - Final
DATE: February 20, 2026

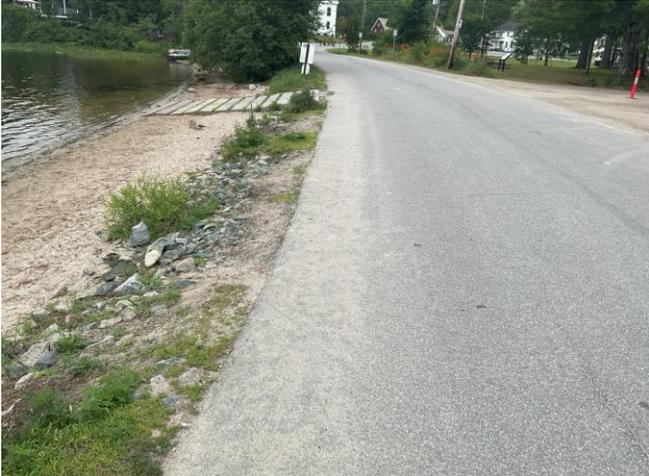
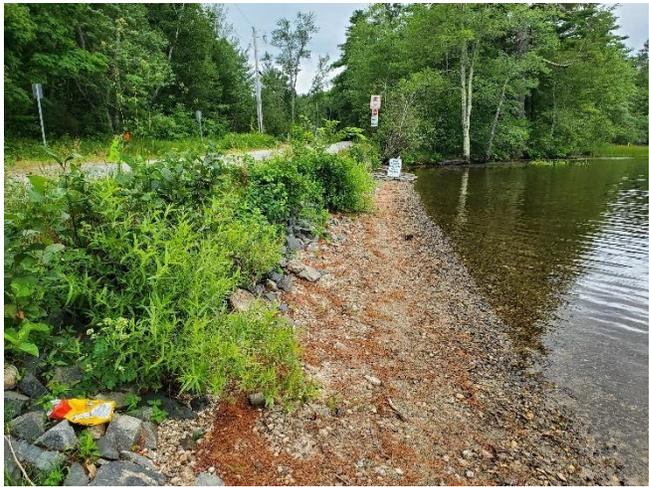
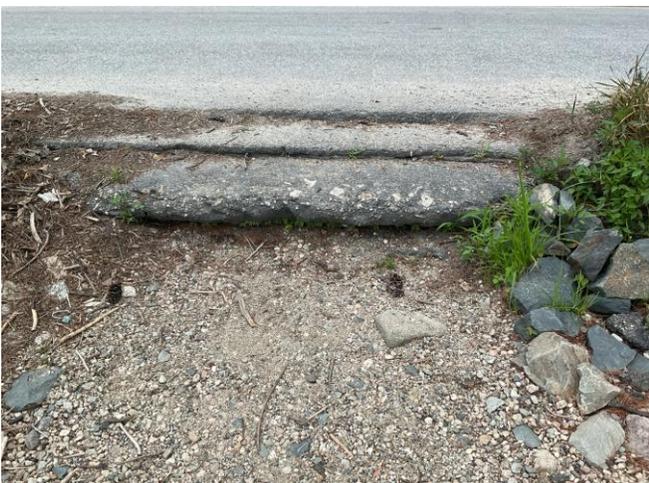
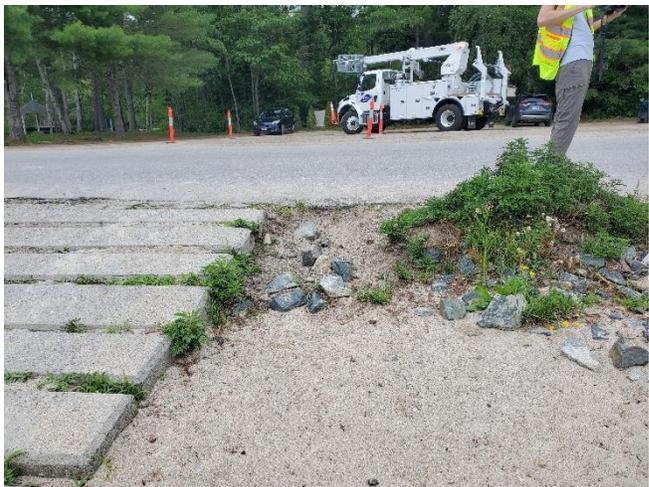
Site 1: Horse Beach	Project Type: Erosion
DESCRIPTION	
<p>Location Description: Wadleigh Hill Road edge on lakeside</p>	<p>Drainage Area Notes:</p>
<p>Issues/Observations: Erosion along approx. 75% of road edge. Sparse vegetation is trampled by pedestrians making their own paths to the beach. Vegetated berm in better condition at south end of beach. Assume about 2 inches of beach erosion over 10 years, based on erosion below asphalt step.</p>	<p>Recommendations: Reestablish vegetative buffer along road shoulder with berm and terrace to manage road/parking lot runoff and reduce beach erosion. Formalize and stabilize several access points to beach.</p>
PHOTOS/SKETCHES

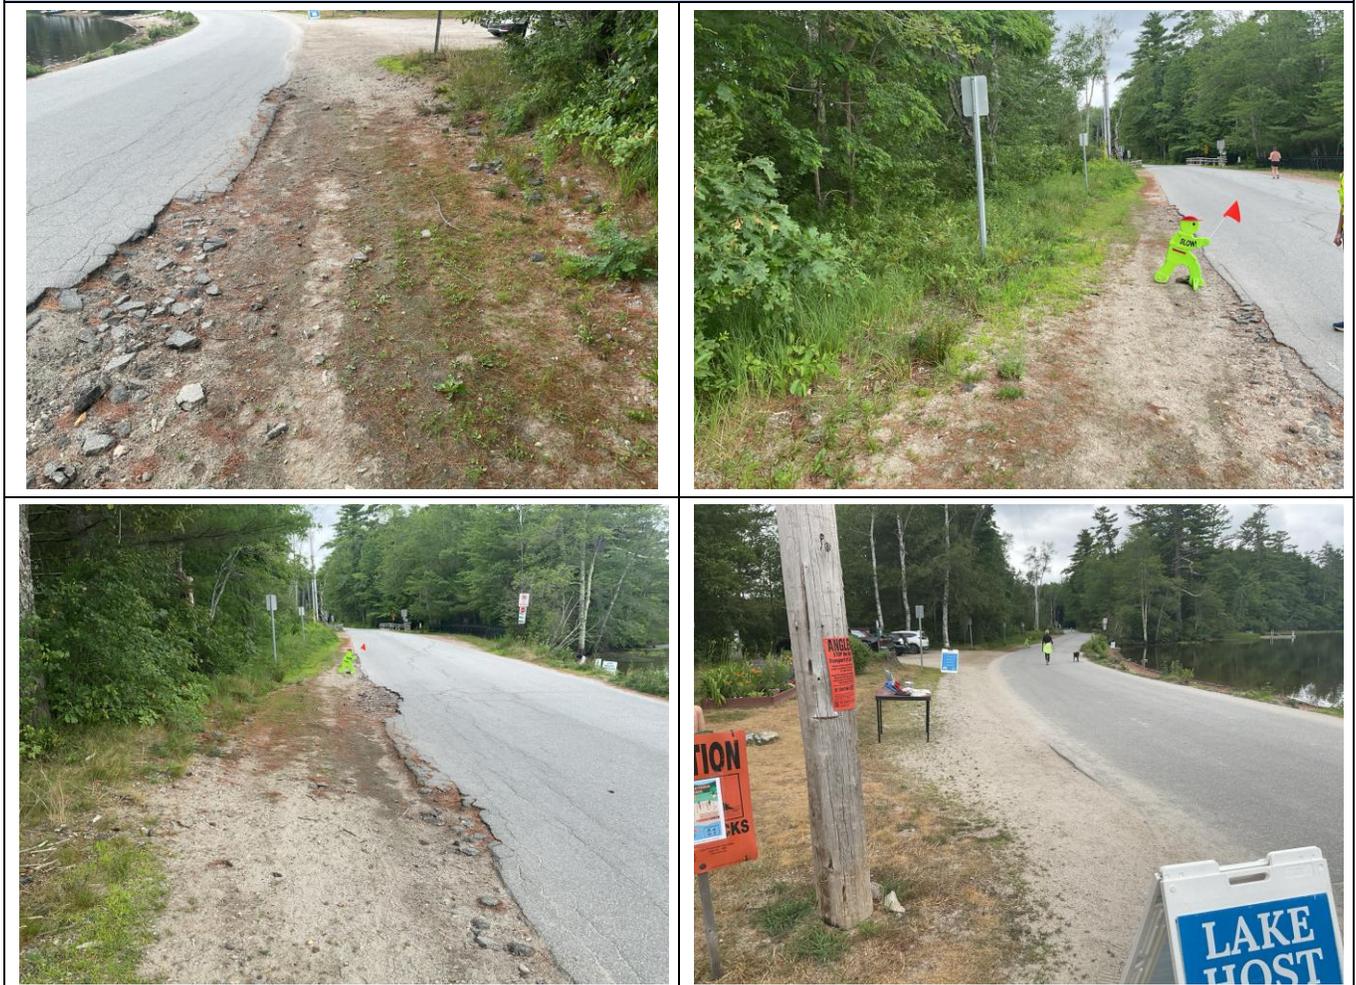
<p>Location Description: Road shoulder between parking lot and dam bridge</p>	<p>Drainage Area Notes:</p>
<p>Issues/Observations: Eroding road shoulder and broken asphalt where vehicles used to park before “no parking” signs were installed.</p>	<p>Recommendations: Revegetate road shoulder to discourage parking and stabilize eroding area. Also consider revegetation or other stabilization between parking lots, in front of lake host station.</p>

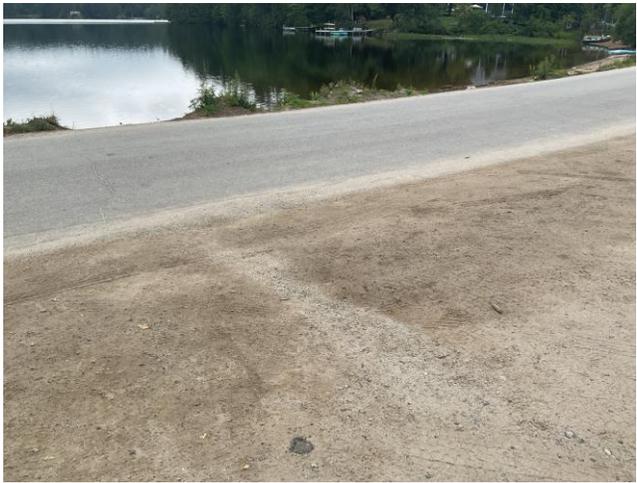
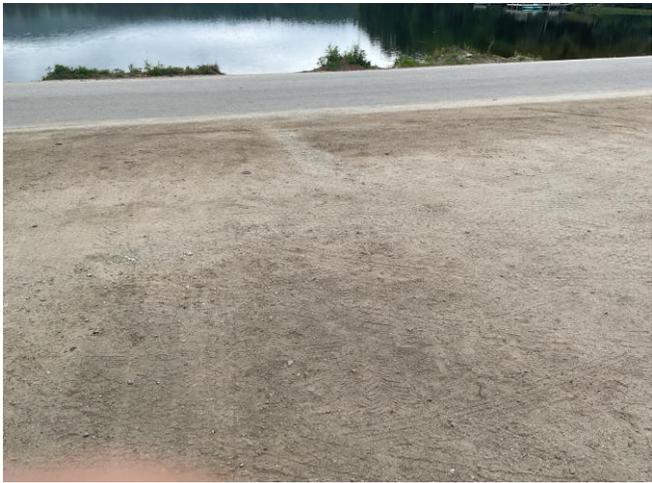
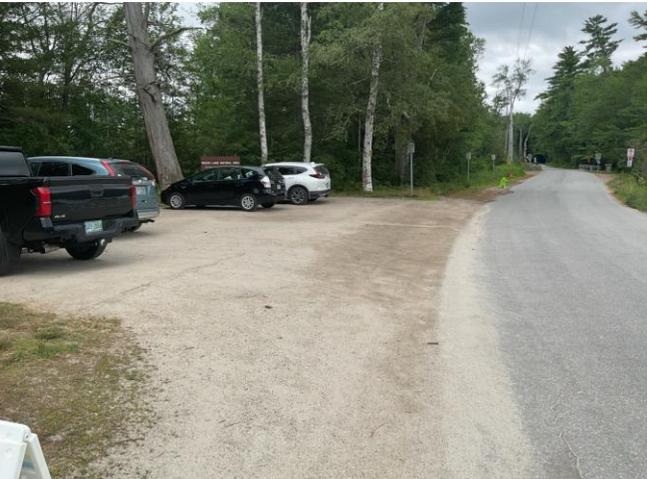
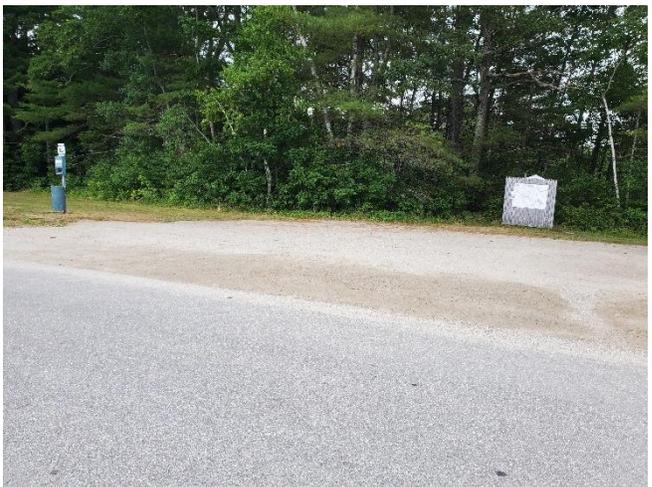
Site 4: Horse Beach south parking lot	Project Type: Erosion
DESCRIPTION	
<p>Location Description: Parking lot closer to bridge</p>	<p>Drainage Area Notes:</p>
<p>Issues/Observations: Gravel parking lot with evidence of puddling, eroded flow paths, and general surface erosion. Sediment washes and gets tracked onto road from parking lot. Parking lot has flooded (from lake) in recent years.</p>	<p>Recommendations: Stabilize gravel parking lot with geogrid or drivable grass pavers. Consider regrading to pitch away from lake and divert runoff into an infiltration practice.</p>
PHOTOS/SKETCHES

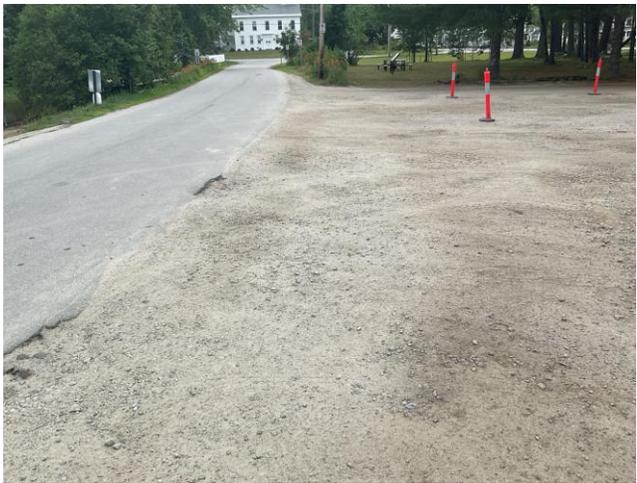
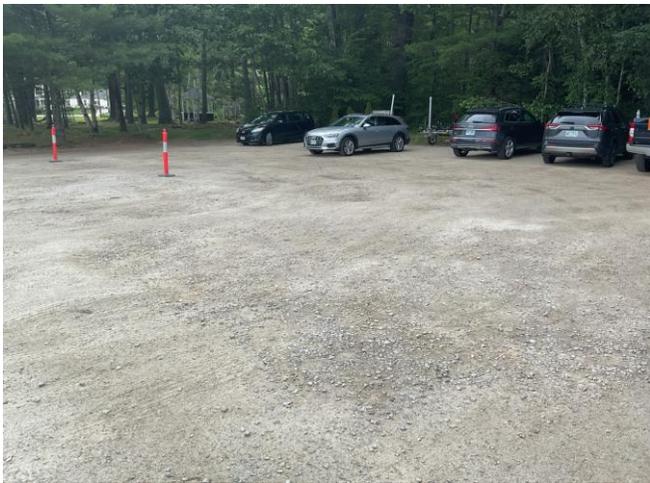
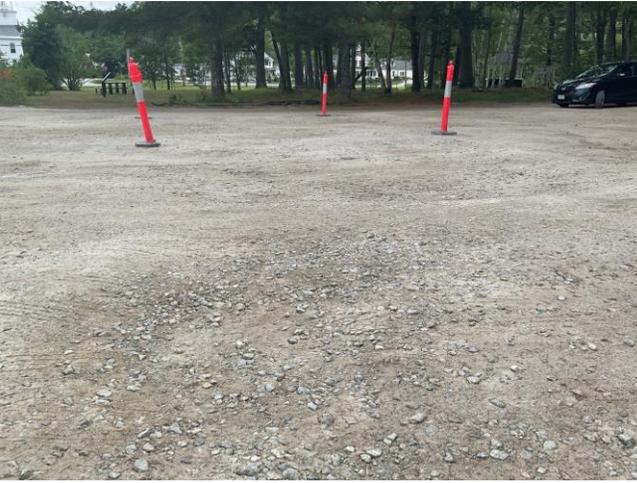
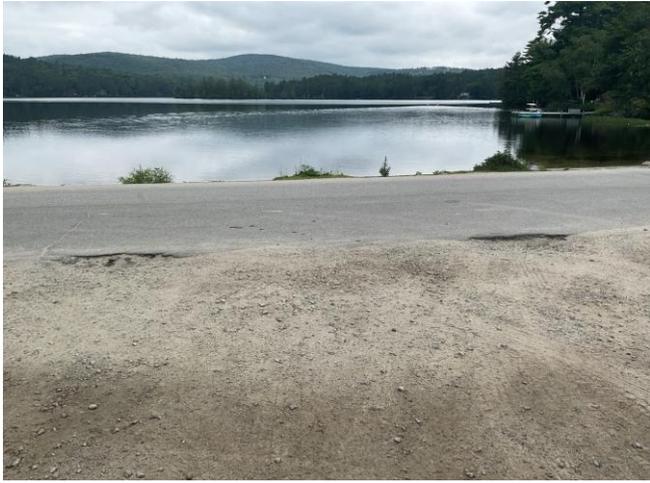
5	Horse Beach parking near boat ramp	Parking lot for boat ramp	Sutton	Private (Kezar Lake Protective Association)	Gravel parking lot with evidence of puddling, eroded flow paths, and general surface erosion. Sediment washes and gets tracked onto road from parking lot.	Stabilize gravel parking lot with geogrid or drivable grass pavers. Consider regrading to pitch away from lake and divert runoff into an infiltration practice.		1.7	3.4	2.0	\$47,000 - \$58,000	6
6	Keyser St culvert	Near 53 Keyser St	Sutton	Town of Sutton	12-inch corrugated metal pipe (CMP) cross culvert at low point. Corroded, partially crushed. Ditch on east side of road leading to culvert is filled with sand, around 6 inches deep and above invert. Sand and debris at outlet.	Clean and reshape ditch. Remove sand and leaves at culvert inlet and outlet. Consider replacing and upsizing culvert. Install sediment forebay at culvert inlet and place cobbles/boulders at outlet to collect leaves and sediment.	DPW cleaned ditch and culvert, installed sumps on both ends of culvert to collect debris. Seeded with VT conservation mix.	0.1	0.2	0.1	\$1,000 - \$1,300	23

Site 5: Horse Beach parking near boat ramp	Project Type: Erosion
DESCRIPTION	
Location Description: Parking lot for boat ramp	Drainage Area Notes:
Issues/Observations: Gravel parking lot with evidence of puddling, eroded flow paths, and general surface erosion. Sediment washes and gets tracked onto road from parking lot.	Recommendations: Stabilize gravel parking lot with geogrid or drivable grass pavers. Consider regrading to pitch away from lake and divert runoff into an infiltration practice.
PHOTOS/SKETCHES

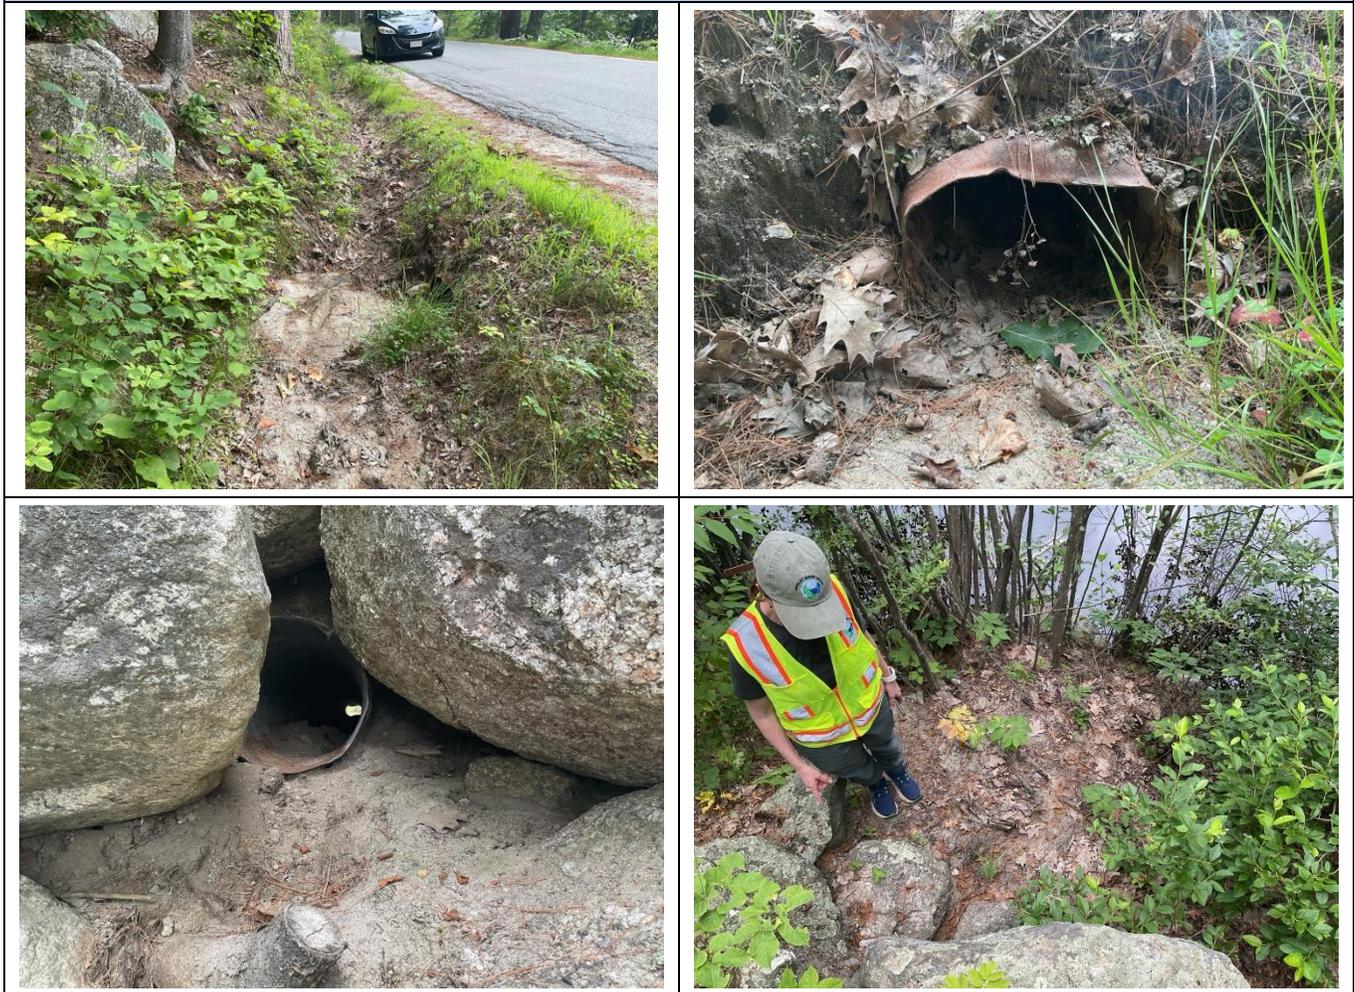
<p>Location Description: Near 53 Keyser St</p>	<p>Drainage Area Notes:</p>
<p>Issues/Observations: 12-inch corrugated metal pipe (CMP) cross culvert at low point. Corroded, partially crushed. Ditch on east side of road leading to culvert is filled with sand, around 6 inches deep and above invert. Sand and debris at outlet.</p>	<p>Recommendations: Clean and expand ditch. Remove sand and leaves at culvert inlet and outlet. Consider replacing and upsizing culvert. Install sediment forebay at culvert inlet and place cobbles/boulders at outlet to collect leaves and sediment.</p>

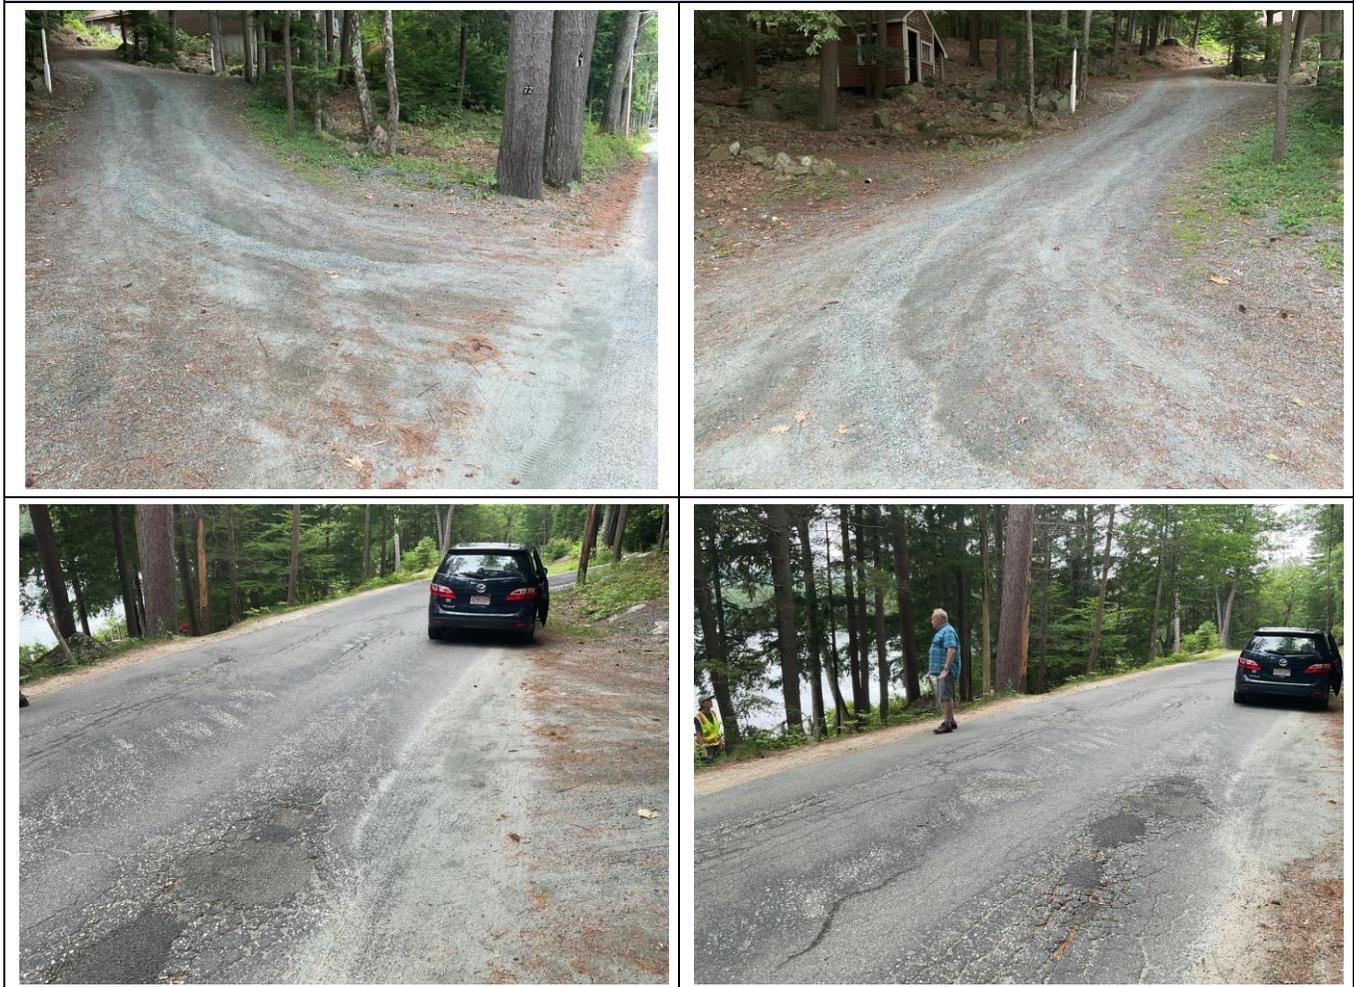
7	Keyser St Driveway	Near high point on Keyser St	Sutton	Private	Sediment washes down gravel driveway across Keyser St into the lake. Possibly washes down steps to lake. Existing basin on the east side of driveway.	Install water bars or rubber razors across driveway to divert runoff into existing basin and reduce erosion.		0.5	1.0	0.6	\$700 - \$1,000	17
8	Keyser St culvert 2	Near conservation property	Sutton	Town of Sutton	12-inch CMP cross culvert, corroded and half filled in. Hose goes through pipe from property up slope. Road sand washes into ditches. Pickerelweed growing near outfall.	Clean and reshape ditch and clean out pipe, inlet, and outlet. Install forebay/stilling basin at inlet and outlet and clean regularly. Revegetate.	DPW cleaned ditch and culvert, installed sumps on both ends of culvert to collect debris. Seeded with VT conservation mix.	0.01	0.03	0.00	\$800 - \$1,000	32

<p>Location Description: Near high point on Keyser St</p>	<p>Drainage Area Notes:</p>
<p>Issues/Observations: Sediment washes down gravel driveway across Keyser St into the lake. Possibly washes down steps to lake. Existing basin on the east side of driveway.</p>	<p>Recommendations: Install water bars or rubber razors across driveway to divert runoff into existing basin and reduce erosion.</p>

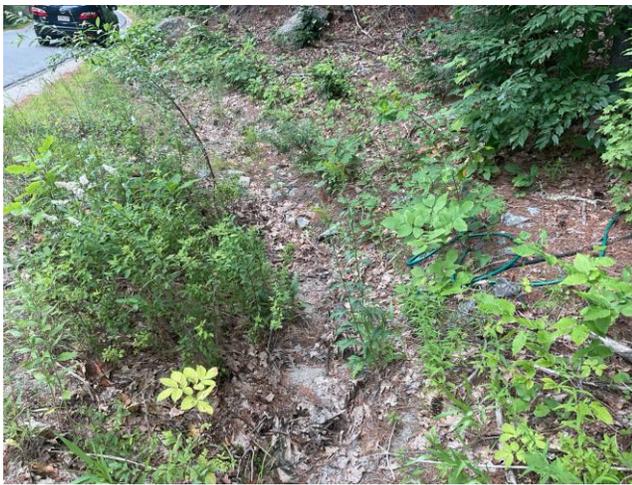
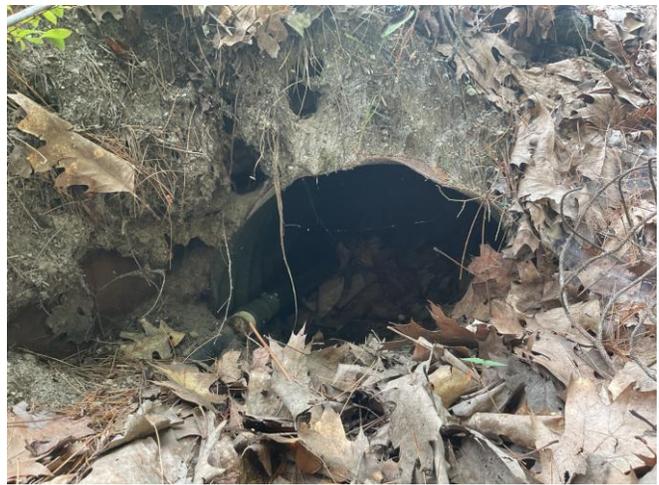
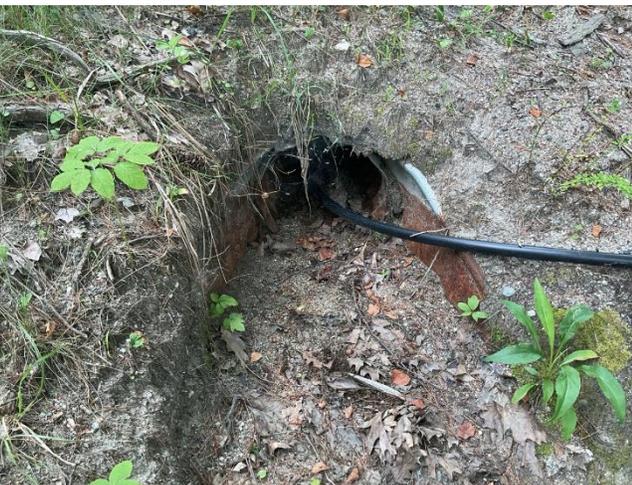
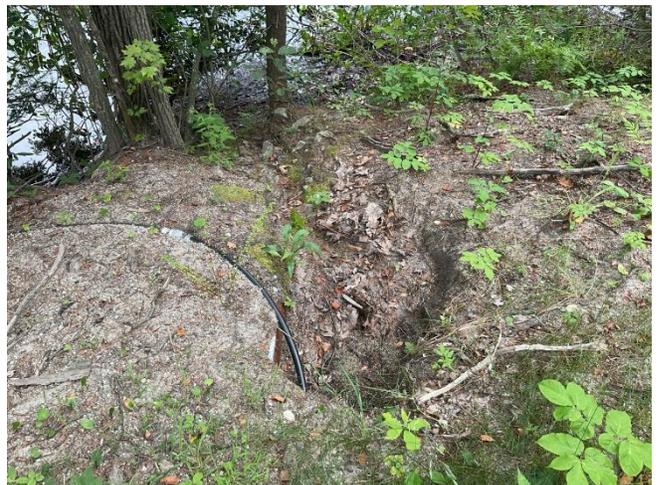
<p>Location Description: Near conservation property</p>	<p>Drainage Area Notes:</p>
<p>Issues/Observations: 12-inch CMP cross culvert, corroded and half filled in. Hose goes through pipe from property up slope. Road sand washes into ditches. Pickerelweed growing near outfall.</p>	<p>Recommendations: Clean and expand ditch and clean out pipe, inlet, and outlet. Install forebay/stilling basin at inlet and outlet and clean regularly. Revegetate.</p>

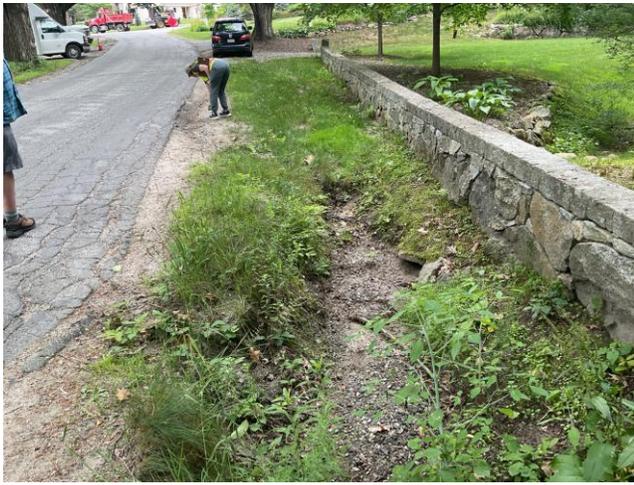
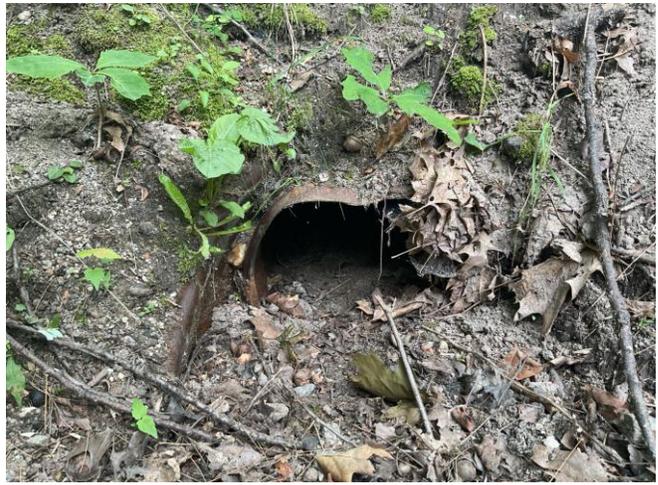
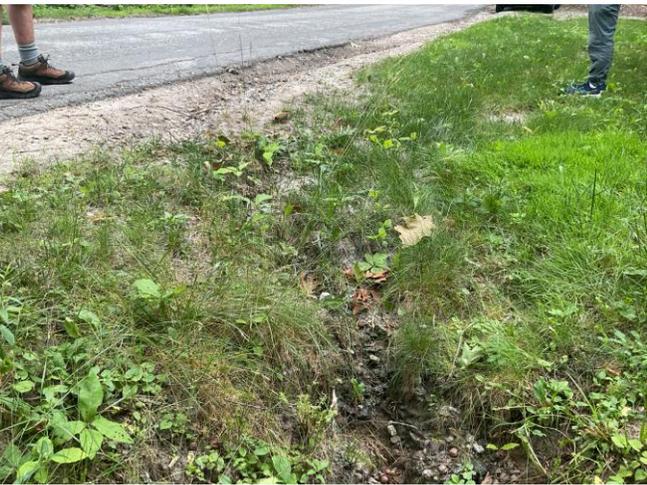
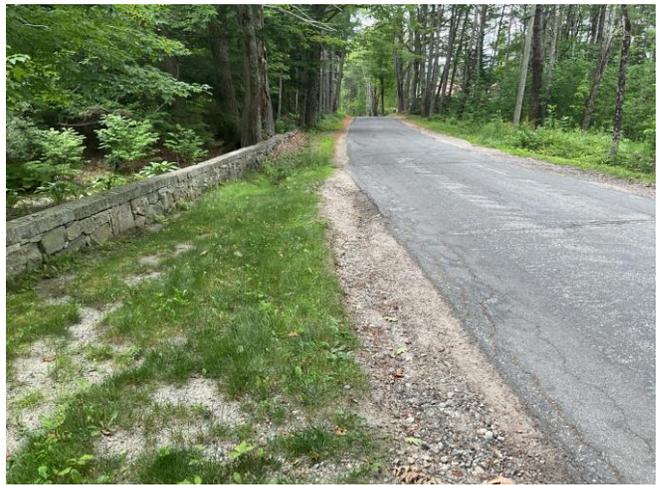
Site 9: Keyser St ditch and crossing	Project Type: Erosion
DESCRIPTION	
Location Description: Downslope of Prospect House	Drainage Area Notes:
Issues/Observations: Corroded 12-inch CMP cross culvert, corroded and half filled with sand from road sanding and eroding flow path along road shoulder above culvert inlet.	Recommendations: Clean ditch and culvert inlet. Formalize and armor road ditch from Prospect House down to inlet.

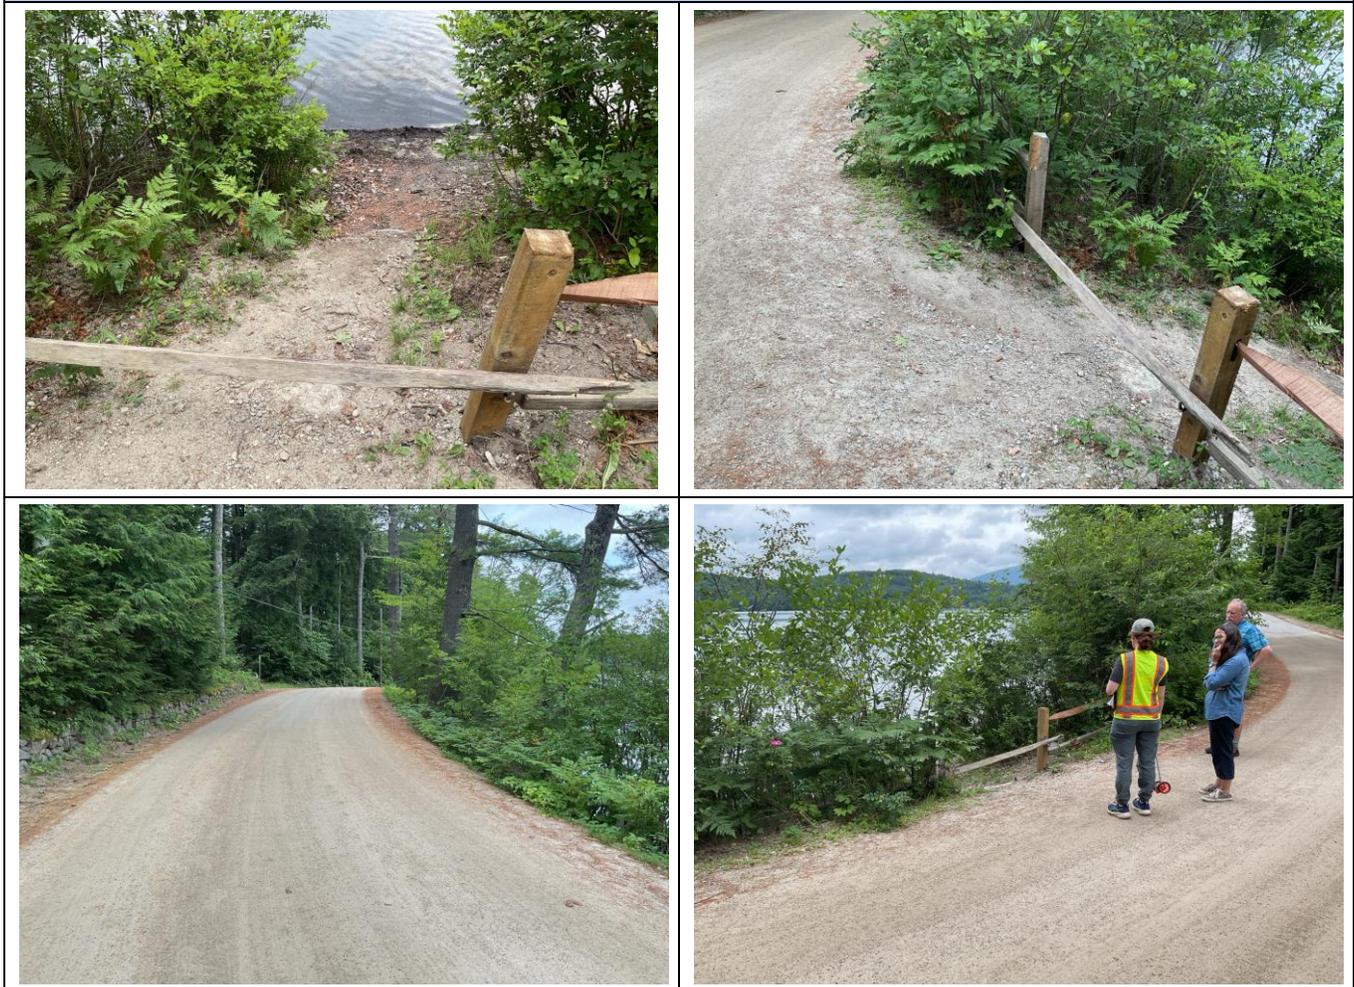
Issues/Observations: Gap in vegetation along shoreline. Eroding private kayak launch at low point in road.	Recommendations: Install two water bars on kayak launch to divert runoff into vegetation. Anchor lumber into ground at an angle; could bury the lumber to secure in place or stake with 2x2-inch stakes or rebar.
--	---

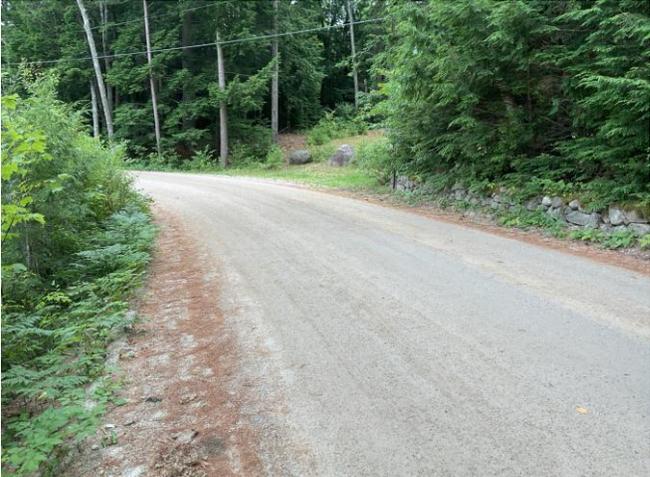
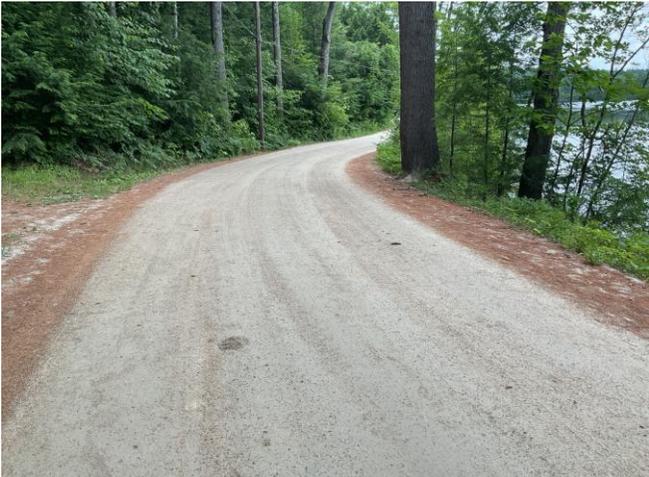
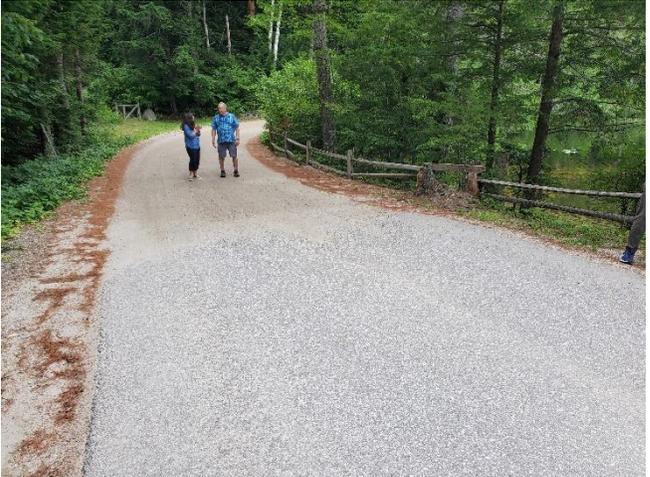
12	Unpaved part of Penacock Rd	Transition from paved to gravel road near 101 Penacock Rd	Sutton	Town of Sutton	Gravel road is 18 ft wide; vehicles primarily use 13 ft drive lane and slow down to pass approaching vehicles. Heavily used by pedestrians. Narrow, steep shoreline buffer with intermittent gullies eroding down to lake. Shoreline vegetation impacted by winter sand and salt.	Improve drainage, stabilize erosion, and restore shoreline buffer along waterfront stretch of gravel road. Expand/maintain ditches on uphill (west) side; add forebays and armoring at cross culverts. Berm on waterfront (east) side, with stabilized outflow at low points. Consider narrowing street to single travel lane with wider pull-off/passing areas, to create space for pedestrian zone and wider shoreline buffer.	DPW has encountered ledge when trying to widen ditch on west side of Penacock Rd.	0.5	1.0	0.5	\$14,000 - \$17,000	18

Site 12: Unpaved part of Penacook Rd	Project Type: Erosion, Buffer
DESCRIPTION	
<p>Location Description: Transition from paved to gravel road near 101 Penacook Rd</p>	<p>Drainage Area Notes:</p>
<p>Issues/Observations: Gravel road is 18 ft wide; vehicles primarily use 13 ft drive lane and slow down to pass approaching vehicles. Heavily used by pedestrians. Narrow, steep shoreline buffer with intermittent gullies eroding down to lake. Shoreline vegetation impacted by winter sand and salt.</p>	<p>Recommendations: Improve drainage, stabilize erosion, and restore shoreline buffer along waterfront stretch of gravel road. Expand/maintain ditches on uphill (west) side; add forebays and armoring at cross culverts. Berm on waterfront (east) side, with stabilized outflow at low points. Consider narrowing street to single travel lane with wider pull-off/passing areas, to create space for pedestrian zone and wider shoreline buffer.</p>

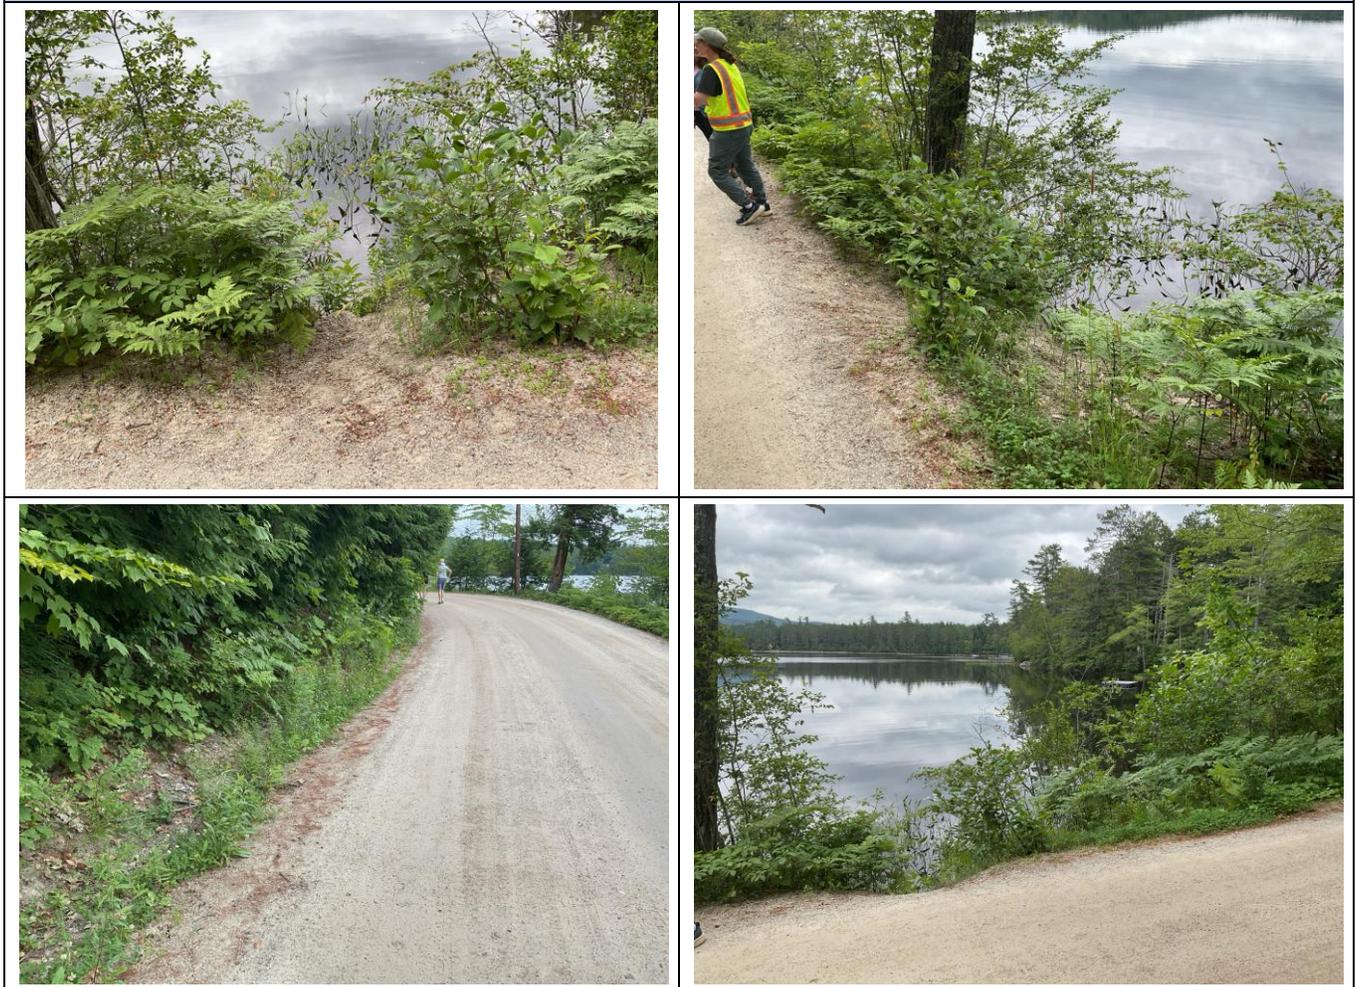
13	Low point on Penacock Rd	North of 101 Penacock Rd, near speed limit sign	Sutton	Town of Sutton	At low point on Penacock Rd, gully erosion and gap in vegetation on shoreline buffer caused by runoff. Road is crowned. It's possible runoff or seepage is coming down hill across road.	Maintain and widen ditch on west shoulder of Penacock Rd to manage runoff from steep hill to west. Stabilize eroding shoreline slope with riprap, level spreader, and vegetation.		0.04	0.07	0.00	\$2,000 - \$3,000	29
14	Penacock Rd informal lake access	Next to utility pole on lake side of road	Sutton	Town of Sutton	Path used for lake access in road shoulder is eroding into lake.	Stabilize eroding slope and install water bars to divert runoff into vegetated buffer or create terracing with boulders.		0.07	0.14	0.1	\$1,100 - \$1,500	25
15	Rowes Creek culvert at Kings Hill	Couple hundred feet from road	Sutton	Town of Sutton	Rowes Creek 48-inch CMP culvert under camp road/trail that is used for fire services and recreation. Above inlet, some bank incision and water flowing under inlet. Recent significant road washout from flooding (now filled with 6 cubic yards of gravel). Ongoing erosion of road above outlet.	Replace stream culvert with open bottom box culvert to prevent further washouts. Stabilize eroding areas.		3.5	7.1	4.2	\$400,000 - \$550,000	3

<p>Location Description: North of 101 Penacook Rd, near speed limit sign</p>	<p>Drainage Area Notes:</p>
<p>Issues/Observations: At low point on Penacook Rd, gully erosion and gap in vegetation on shoreline buffer caused by runoff. Road is crowned. It's possible runoff or seepage is coming down hill across road.</p>	<p>Recommendations: Maintain and widen ditch on west shoulder of Penacook Rd to manage runoff from steep hill to west. Stabilize eroding shoreline slope with riprap, level spreader, and vegetation.</p>

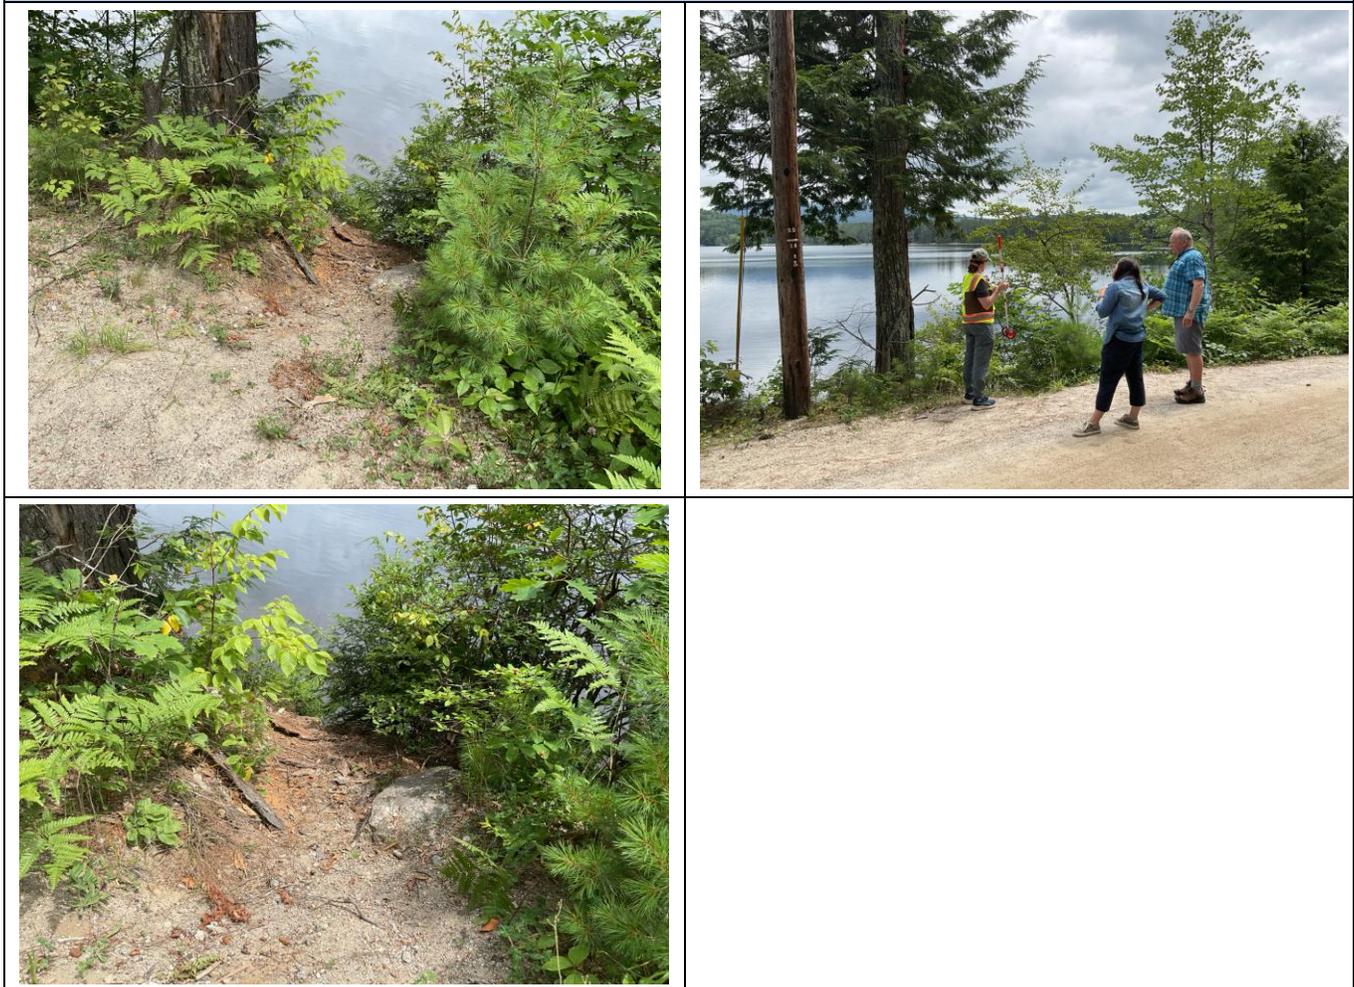
<p>Location Description: Next to utility pole on lake side of road</p>	<p>Drainage Area Notes:</p>
<p>Issues/Observations: Path used for lake access in road shoulder is eroding into lake.</p>	<p>Recommendations: Stabilize eroding slope and install water bars to divert runoff into vegetated buffer or create terracing with boulders.</p>

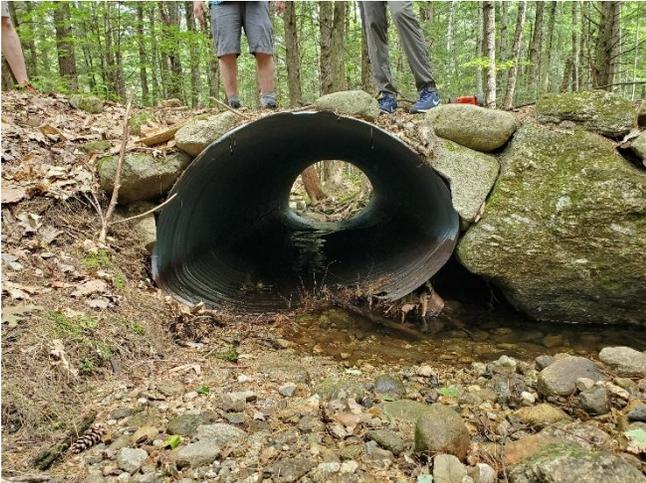
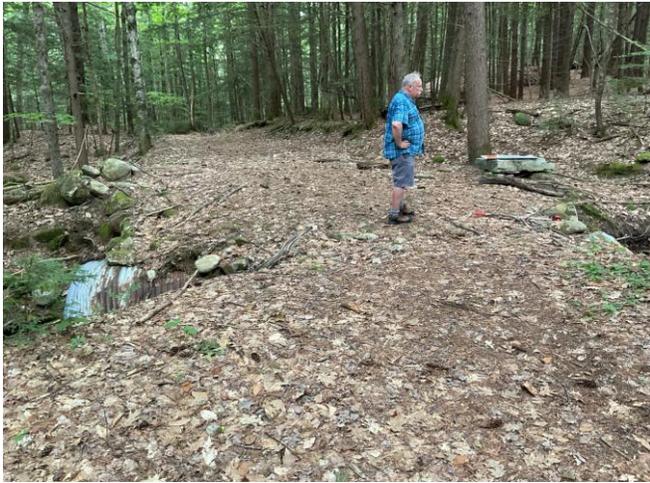
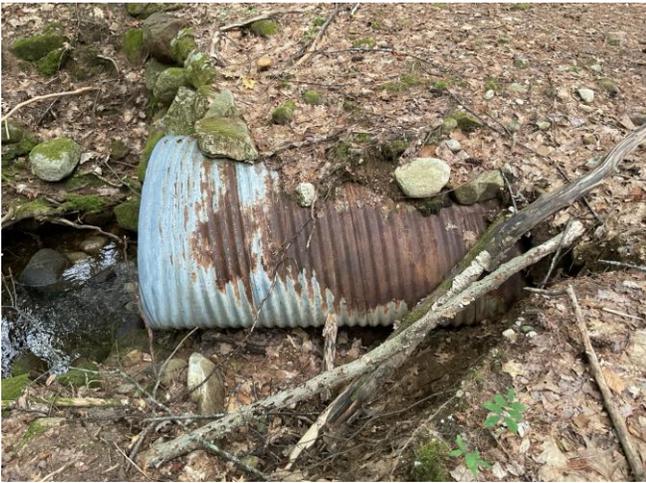
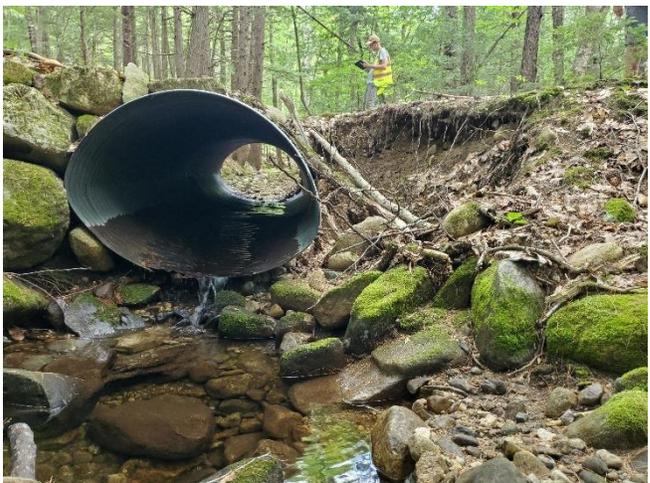
Site 15: Rows Creek culvert at Kings Hill	Project Type: Erosion
DESCRIPTION	
<p>Location Description: Couple hundred feet from road</p>	<p>Drainage Area Notes:</p>
<p>Issues/Observations: Rows Creek 48-inch CMP culvert under camp road/trail that is used for fire services and recreation. Above inlet, some bank incision and water flowing under inlet. Recent significant road washout from flooding (now filled with 6 cubic yards of gravel). Ongoing erosion of road above outlet.</p>	<p>Recommendations: Replace stream culvert with open bottom box culvert to prevent further washouts. Stabilize eroding areas.</p>
PHOTOS/SKETCHES

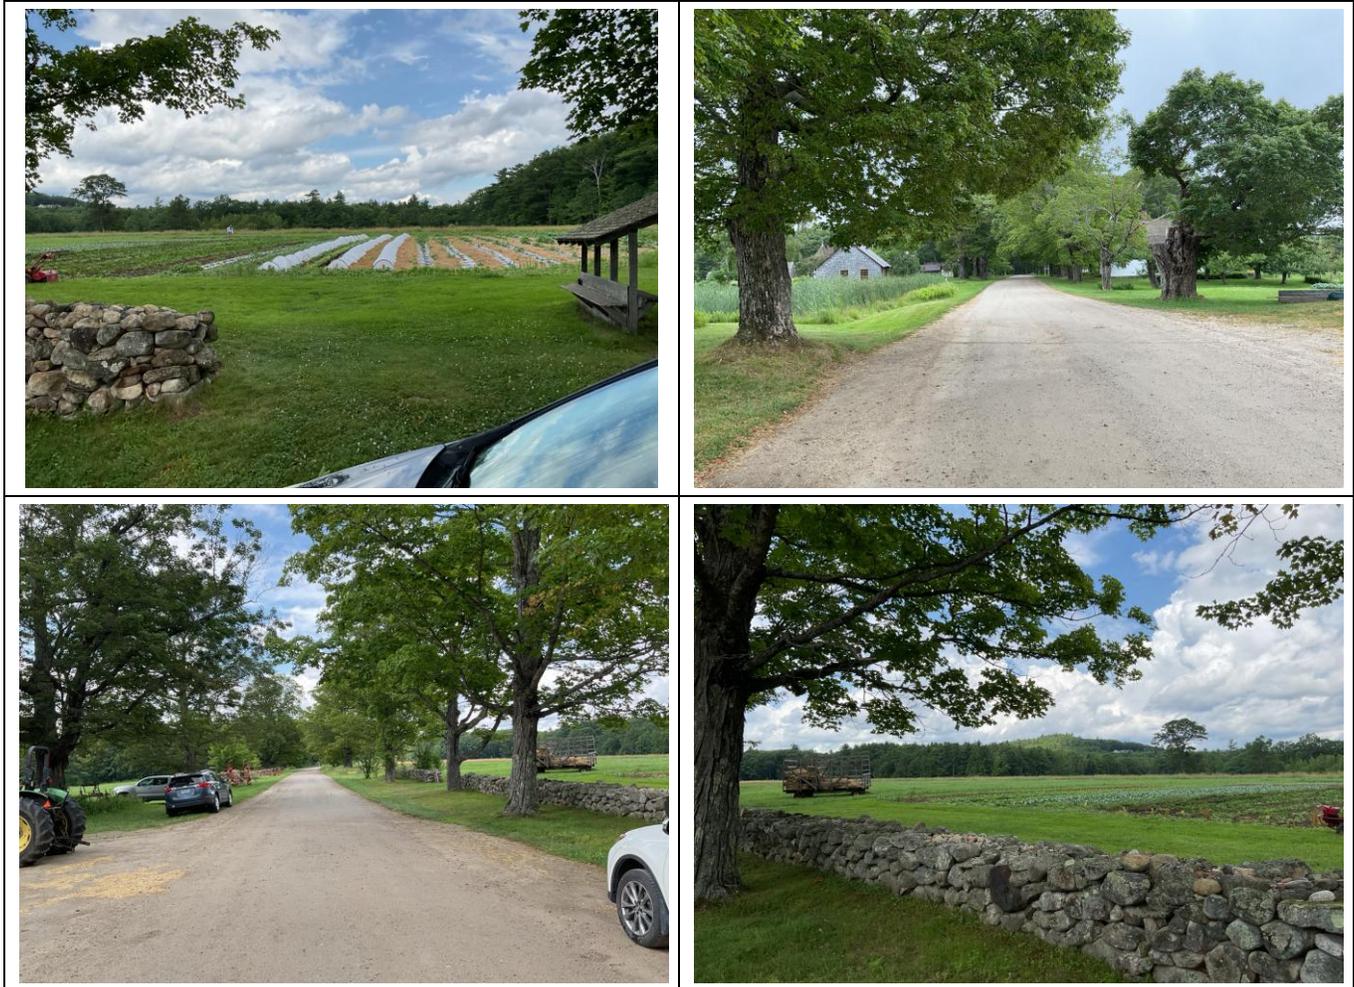
<p>Location Description: Harvey Rd</p>	<p>Drainage Area Notes:</p>
<p>Issues/Observations: Crop fields, apple orchard, a few animals, and small-scale timber harvest for firewood. Organic fertilizers. No detention ponds except one small fire pond. Not much runoff. Adequate forest buffer around fields. Farm staff expressed concern that sugar maples along Harvey Rd may be impacted by excessive winter salting.</p>	<p>Recommendations: Consider reduced salting along Harvey Rd.</p>

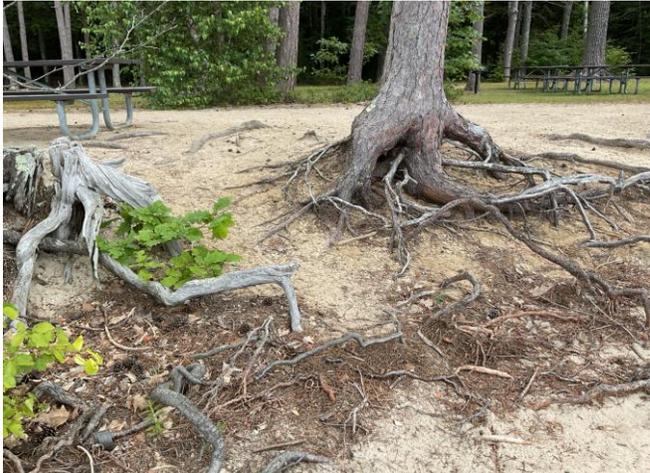
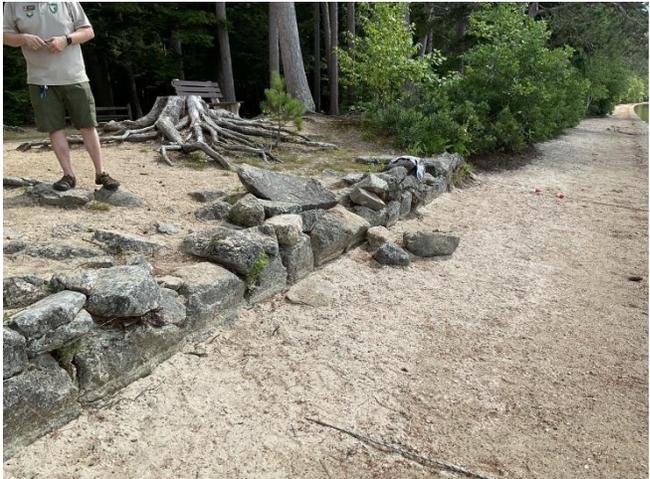
Site 17: Wadleigh State Park beach	Project Type: Erosion, Buffer
DESCRIPTION	
<p>Location Description: Entire beach</p>	<p>Drainage Area Notes:</p>
<p>Issues/Observations: Long stretch of sandy beach below line of pine trees, path, and picnic areas. Erosion around exposed tree roots. Eroding informal access points to beach at breaks in vegetation. Beach sand is regularly dragged/combed but not replenished. Retaining wall in one section (see photo). Lake level rises to picnic tables and path after big storms. Erosion is accelerating.</p>	<p>Recommendations: Construct a retaining wall below tree line (similar to existing) and restore vegetated buffer above beach. Plant a more diverse forest mix in areas of open canopy or where dead, diseased, or hazard trees will be removed (existing red pines and hemlocks are threatened by disease). Formalize steps and paths to parking lot and beach to discourage unauthorized paths, which can cause erosion.</p>
