WATERSHED SURVEY RESULTS MEMORANDUM

TO: Town of Sutton, NH and Kezar Lake Protective Association
FROM: Lori Kennedy, Horsley Witten Group and Christine Bunyon, FB Environmental Associates
SUBJECT: Kezar Lake Watershed Survey Results - Final
DATE: February 20, 2026

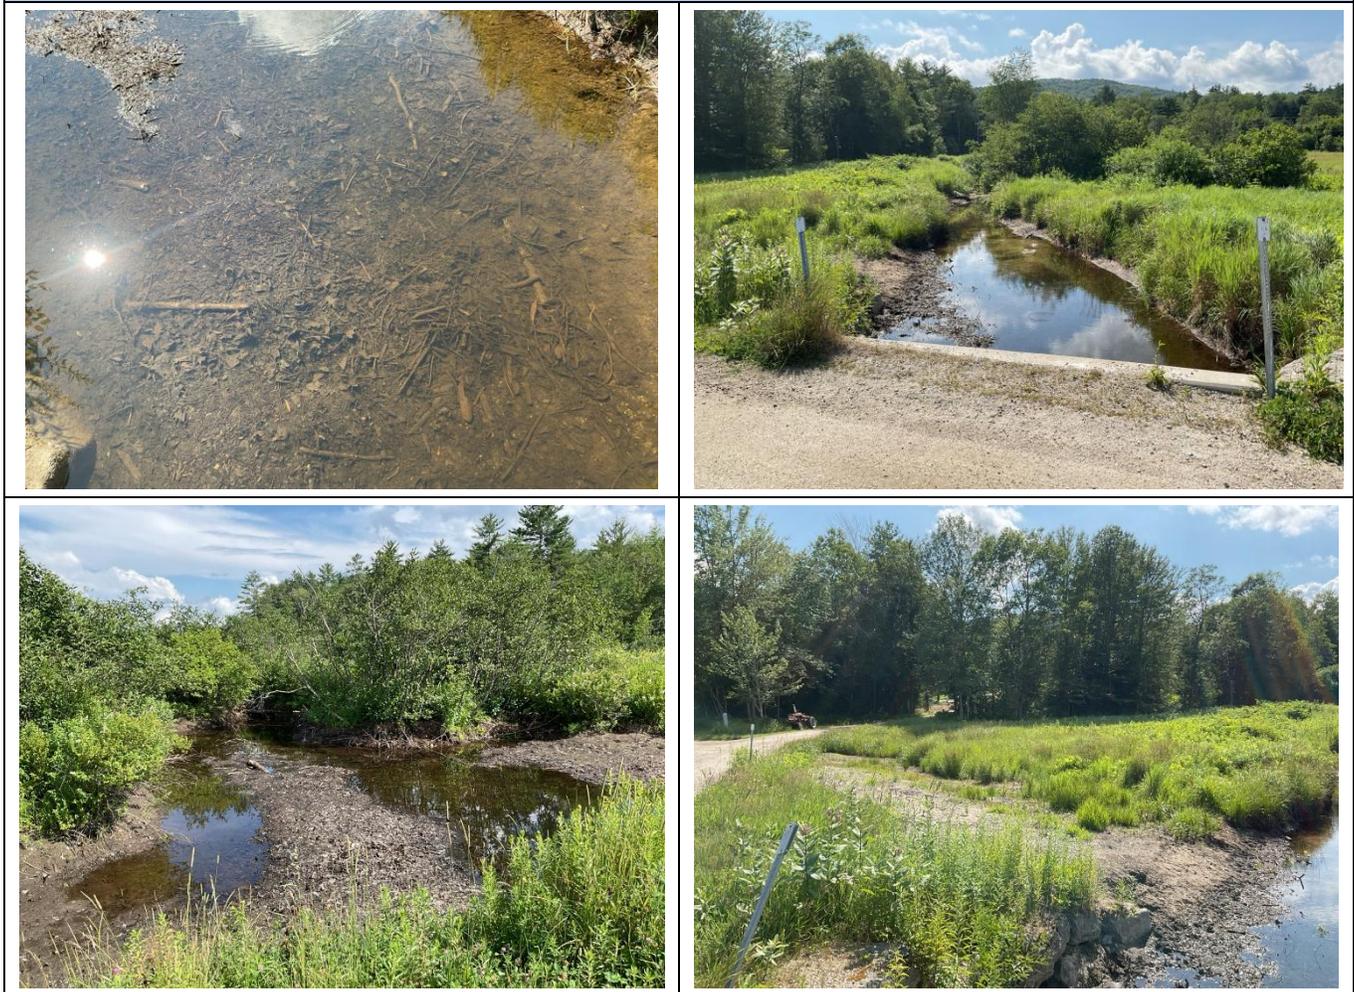
Issues/Observations: Open bottom box culvert under Penacook Rd. Landowners dredge stream and dig/clear banks and buffer periodically. Stream bottom is covered with fine sediment and organic matter, very different from gravel/cobble streambed on Kings Hill.	Recommendations: Discontinue stream dredging and streambank clearing, except as permitted by NHDES. Investigate and control source(s) of fine sediment and organics. Hire a stream geomorphologist to advise on stream restoration. Stabilize and revegetate stream bank and buffer.
--	--

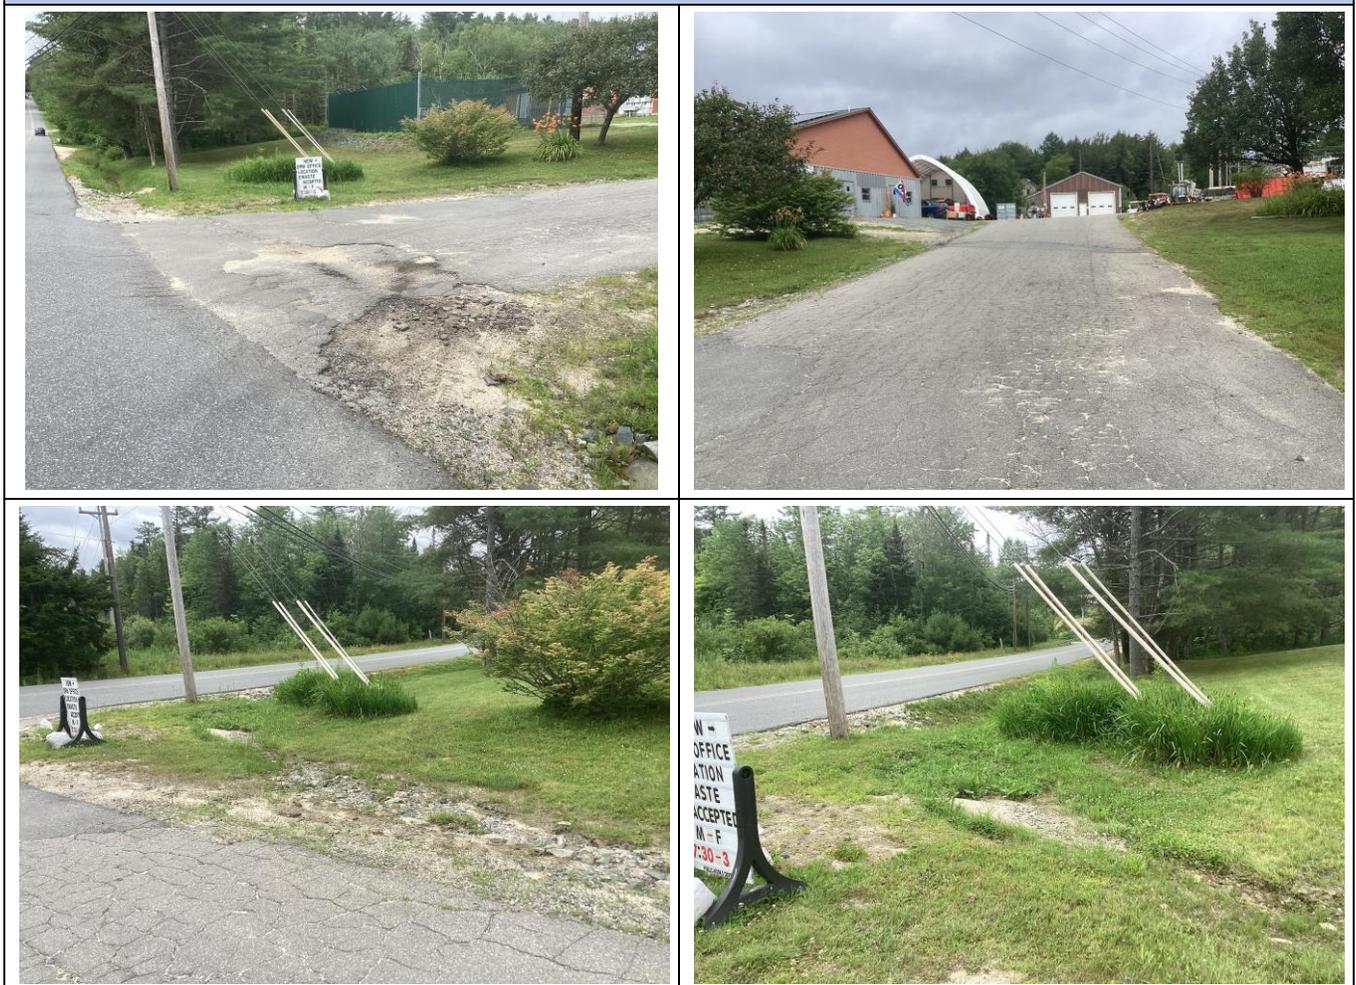
<p>Location Description: Southern driveway, south corner of intersection</p>	<p>Drainage Area Notes: Drainage area appears to include half or more of garage roof, red building roof, entrance driveway, and a portion of the paved parking areas within DPW.</p>
<p>Issues/Observations: Runoff runs down driveway to grass shoulder, some gravel and sand accumulation.</p>	<p>Recommendations: Install bioretention basin at corner of DPW entrance and S Pleasant Street for stormwater treatment.</p>

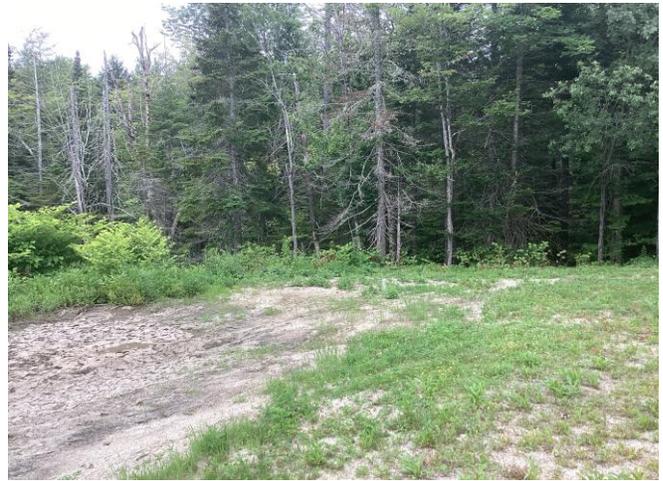
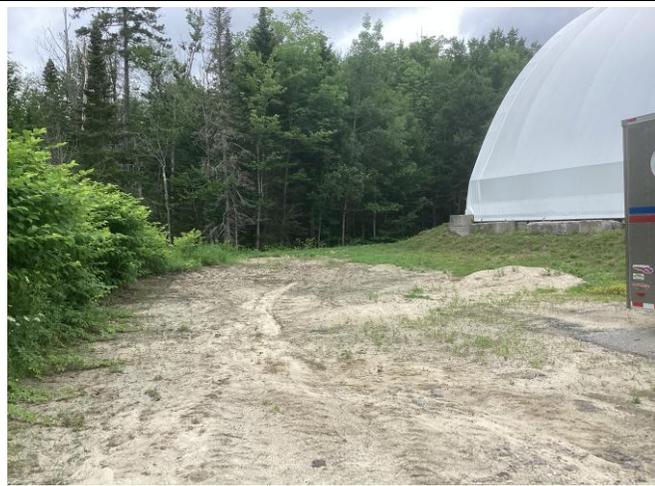
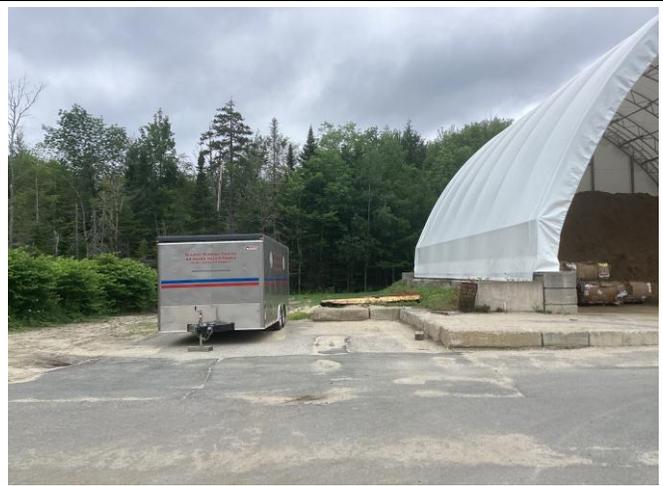
101	New London DPW Existing stormwater area	South of salt shed, abutting berm and stream buffer	New London	Town of New London	Shallow stormwater pond with fabric and stone below ground for infiltration. Very rarely will water rise up and overflow over berm. This area is also used for snow storage.	Replace existing shallow stormwater pond with bioretention area.	New London DPW yard is being redesigned.	0.7	6.1	0.00	\$34,000 - \$42,000	12
102	New London DPW Northern driveway	Entrance of northern driveway	New London	Town of New London	Existing plastic culvert is starting to collapse, lots of water flows down to culvert. Water overtops culvert and flows down road. Armored ditch will fill up to road in large storm.	Culvert replacement. Consider upsizing culvert. DPW is considering removing this entrance in redevelopment project. If this is the case, consider a larger settling basin in location of entrance.	New London DPW yard is being redesigned.	NA	NA	NA	NA	NA

Issues/Observations:
Existing shallow stormwater pond with fabric and stone below ground for infiltration. Very rarely will water rise up and overflow over berm. This area is also used for snow storage.

Recommendations:
Replace existing shallow stormwater pond with bioretention area.

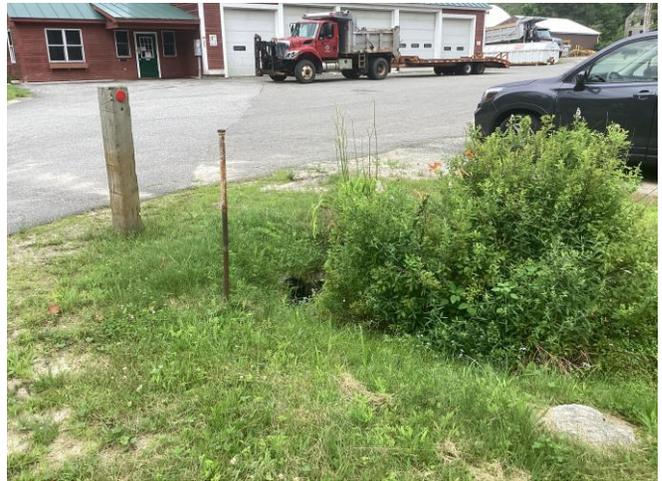
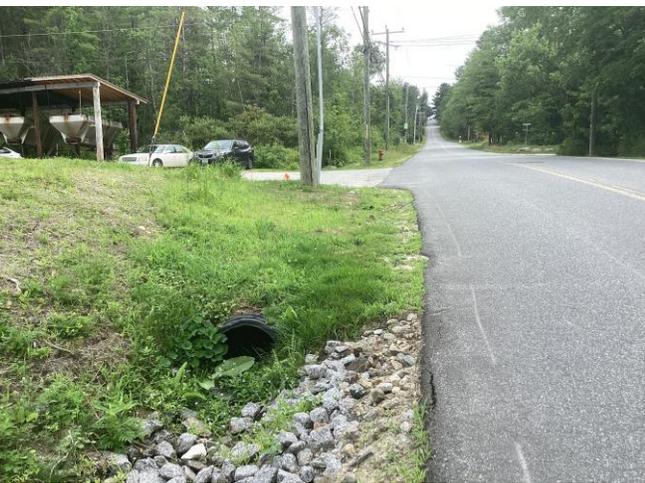
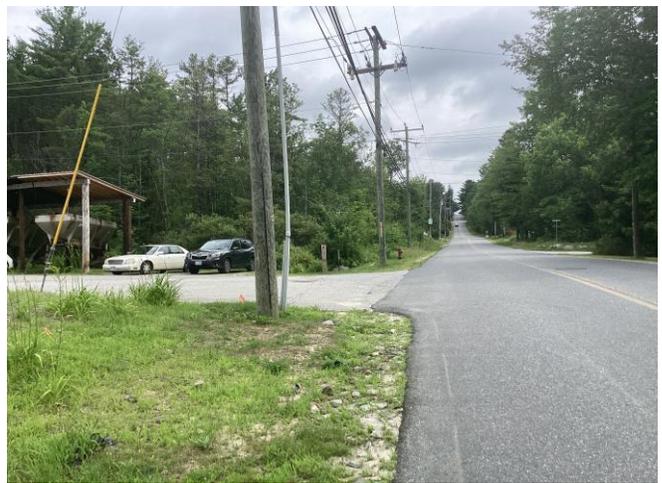
<p>Issues/Observations: Existing plastic culvert is starting to collapse, lots of water flows down to culvert. Water overtops culvert and flows down road. Armored ditch will fill up to road in large storm.</p>	<p>Recommendations: Culvert replacement. Consider upsizing culvert. DPW is considering removing this entrance in redevelopment project. If this is the case, consider a larger settling basin in location of entrance.</p>
--	---

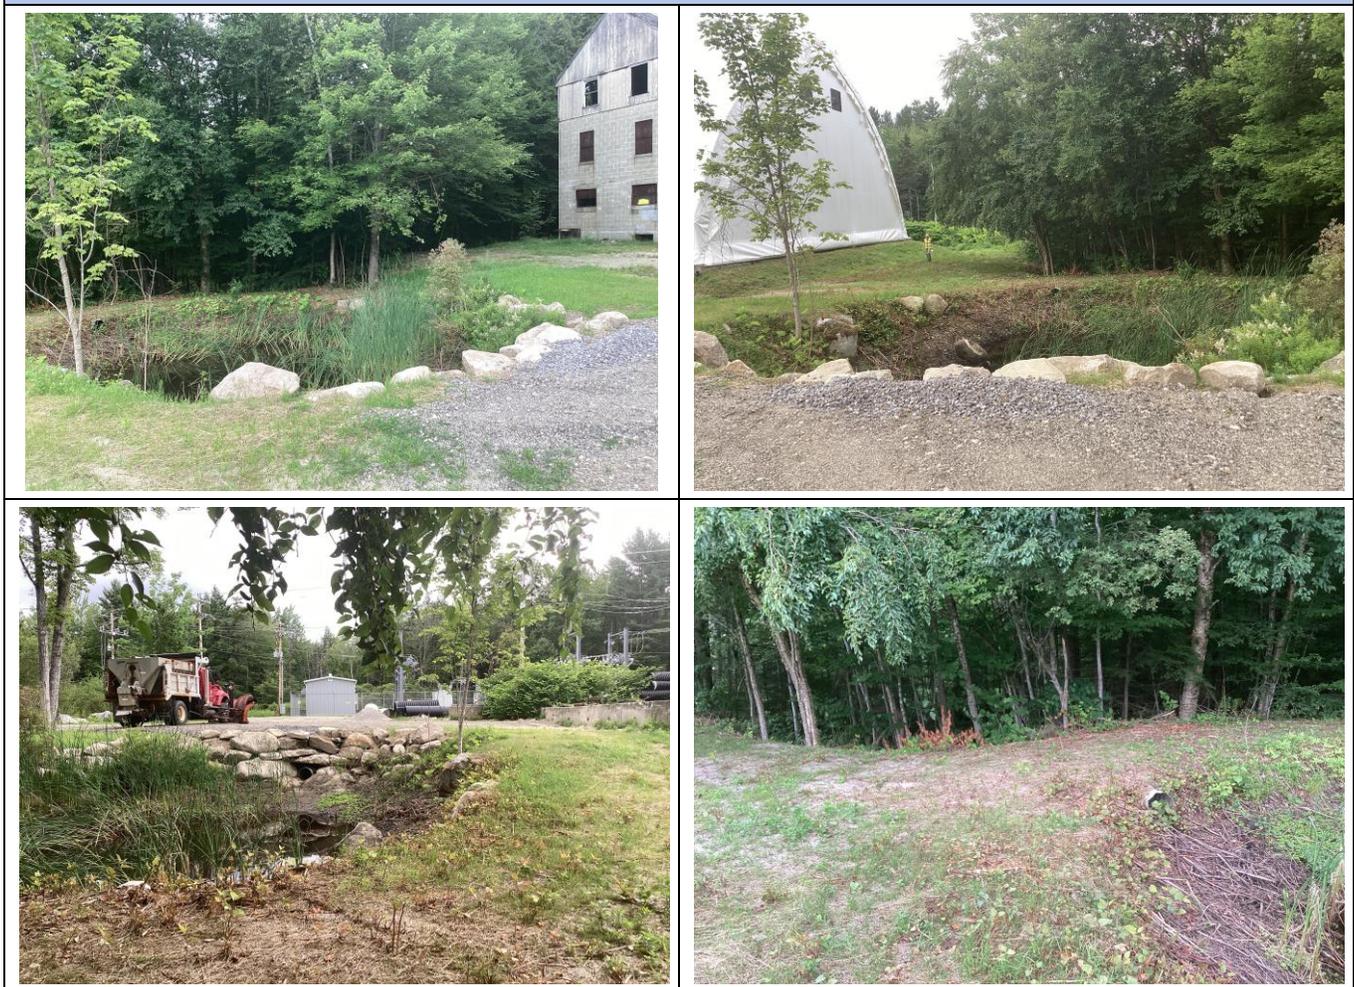
<p>Location Description: Behind salt shed and next to firefighter training structure</p>	<p>Drainage Area Notes: Drainage area is sand and gravel.</p>
<p>Issues/Observations: Existing retention pond. Gravel driveway runs into retention pond, overtops rock wall. Piled gravel to prevent overtop. Runoff runs down sides.</p>	<p>Recommendations: Add one or two deep sump catch basins to gravel parking area and outlet to retention pond.</p>

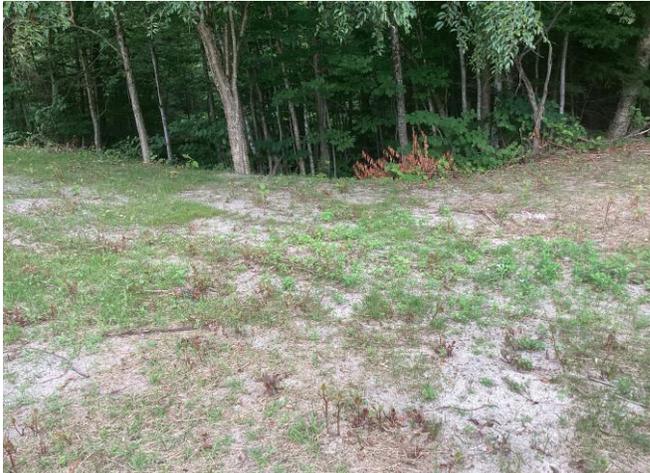
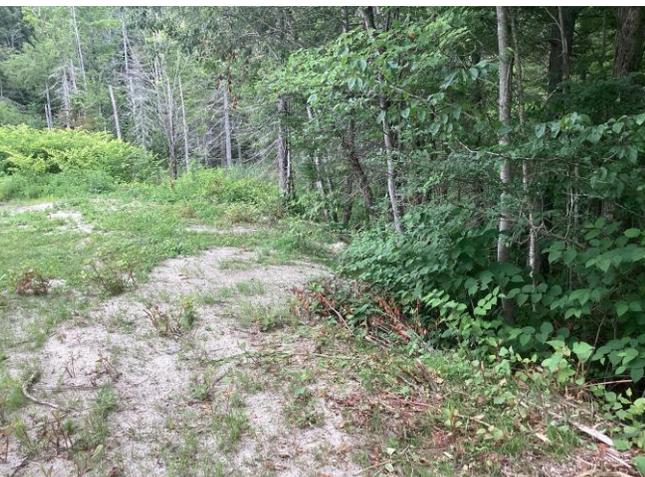
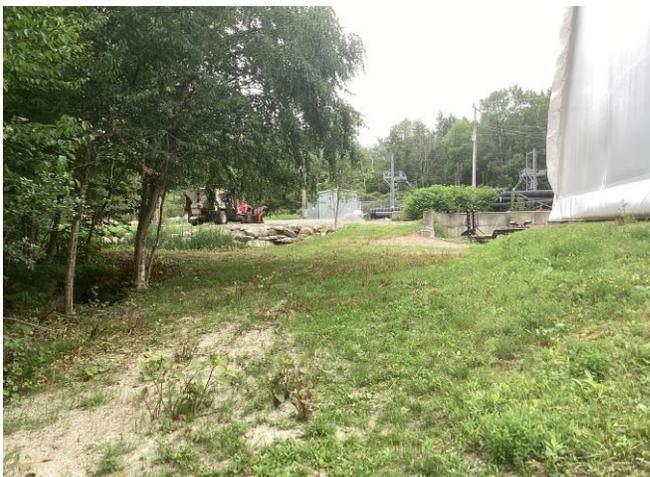
Site 104: New London DPW behind salt shed	Project Type: Buffer
DESCRIPTION	
Location Description: Behind salt shed along forest/wetland edge	Drainage Area Notes:
Issues/Observations: Some sand washing over edge.	Recommendations: Extend berm around corner and behind shed up to retention pond. Revegetate behind shed.
PHOTOS/SKETCHES

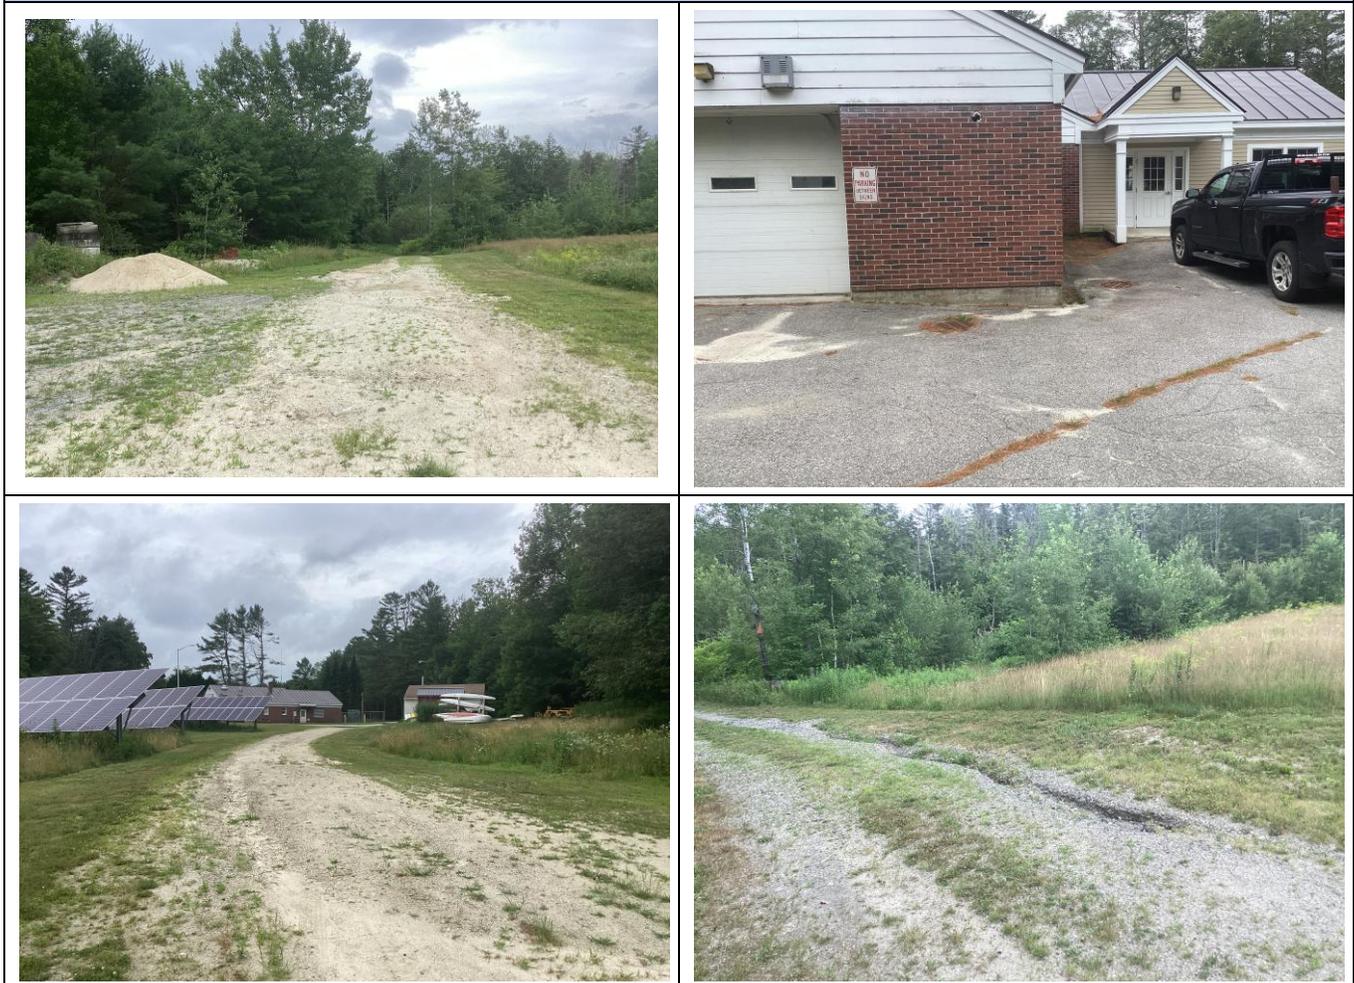
Location Description: Maintenance road and retired sewage plant	Drainage Area Notes:
Issues/Observations: Gullying and gravel/sand road. Pile of sand next to streambank.	Recommendations: Resurface road with larger stone. Remove sand pile. Clean out catch basins around building.

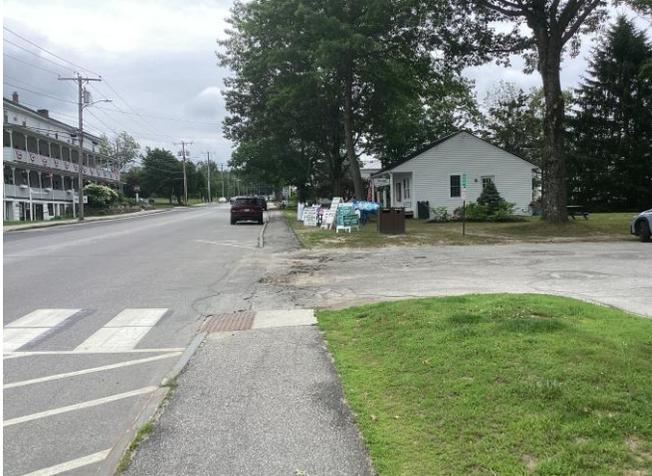
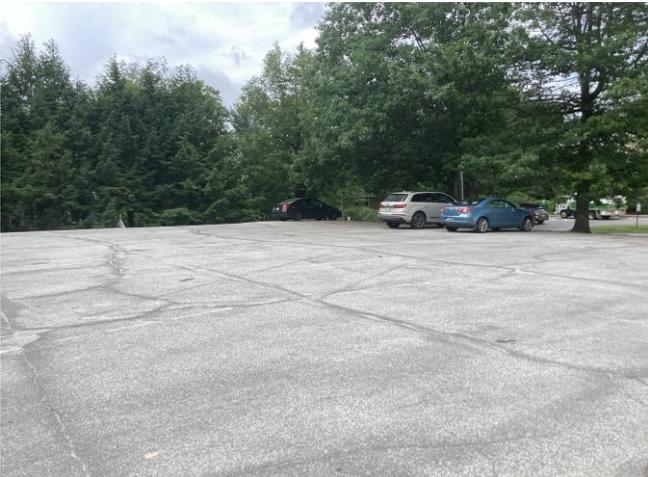
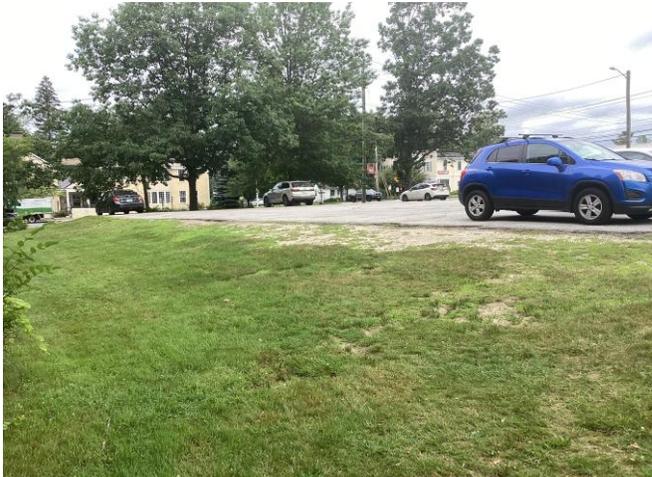
Site 106: Municipal lot	Project Type: Stormwater
DESCRIPTION	
<p>Location Description: Municipal lot at intersection of S. Pleasant St and Main St</p>	<p>Drainage Area Notes: Parking lot.</p>
<p>Issues/Observations: Large paved parking lot with no stormwater treatment. Sediment accumulation in northwest corner. Damaged pavement and sediment accumulation at entrance from standing water due to poor drainage.</p>	<p>Recommendations: Bioretention in northwest corner. Consider re-grading and striping parking lot. Regrade entrance of parking lot to keep road runoff in road. Consider landscape/bioswale island and second stormwater practice in southeast corner.</p>
PHOTOS/SKETCHES

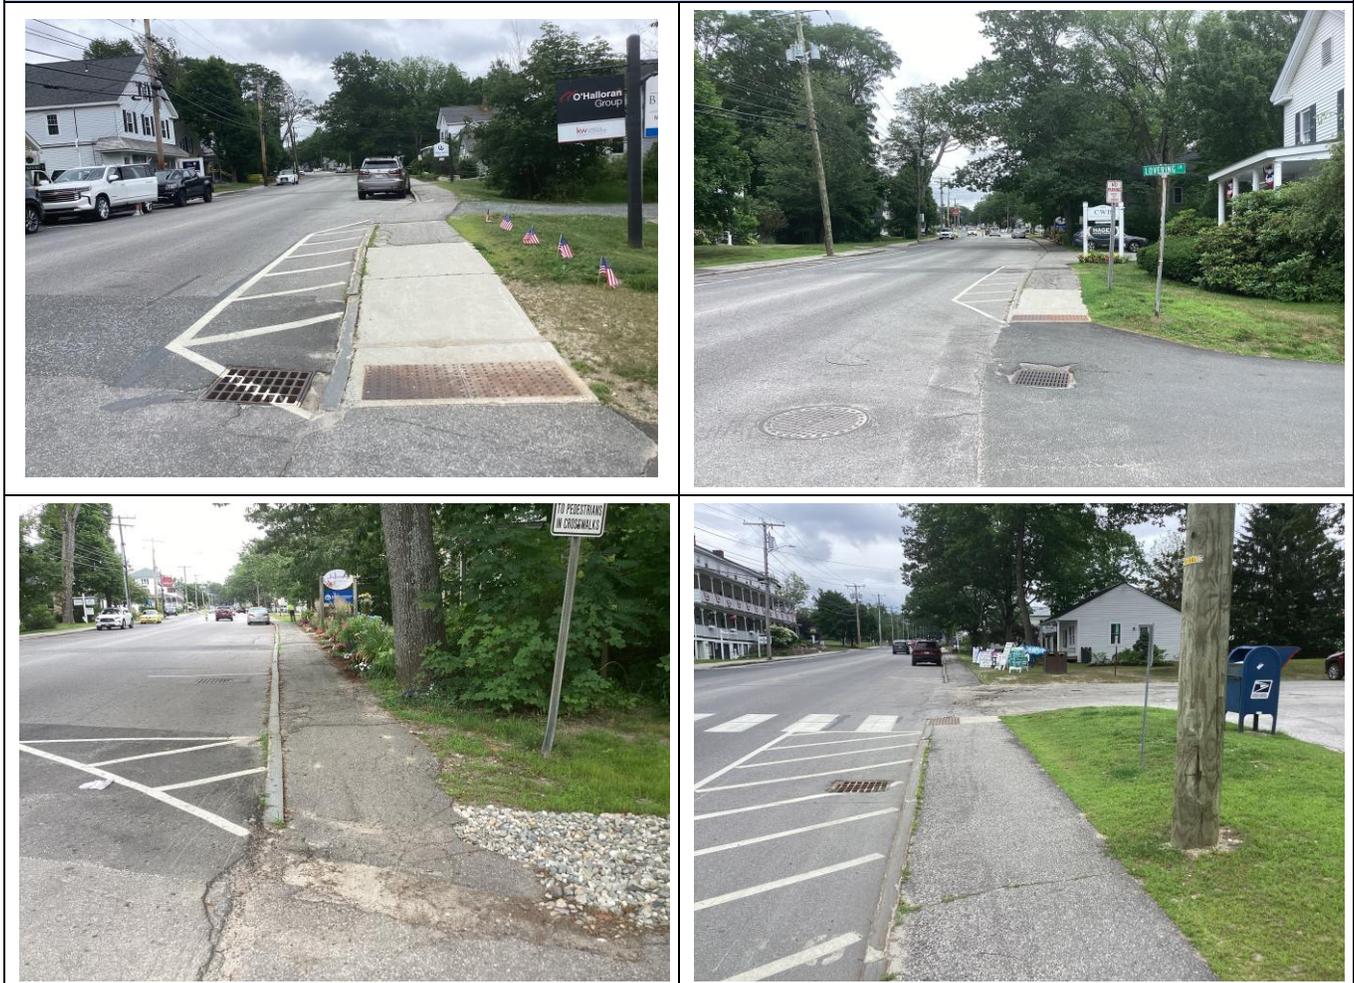
Issues/Observations: Catch basins do not run along gutter line/flow path. Runoff appears to bypass catch basins and turns down side roads or driveways. Business implementing armored flow path to improve eroded areas. Damaged pavement at side roads/driveways.	Recommendations: Adjust inlet grate placement or curb line/berm to prevent bypass. Clean out catch basins or replace. Install infiltration tree trenches to treat runoff diverted from catch basins where possible. Re-grade driveway or side road entrances to keep runoff in road.
--	--

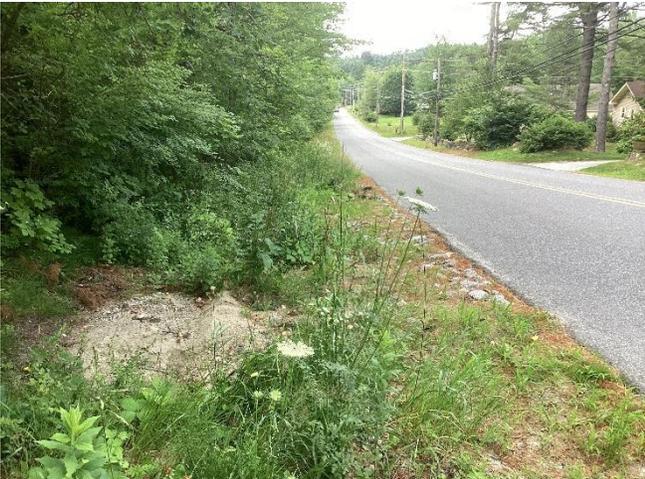
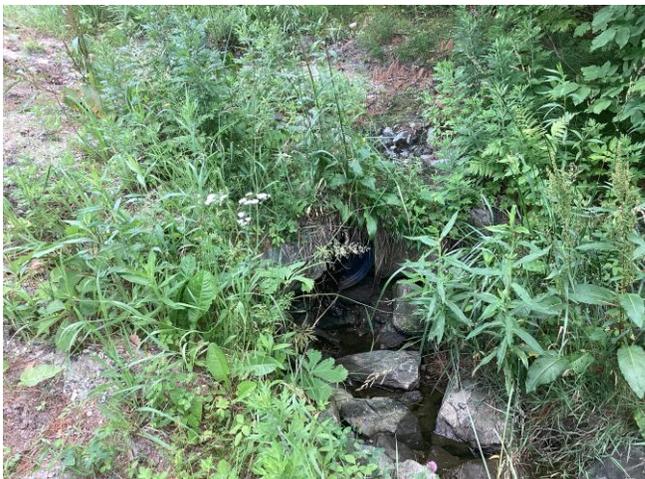
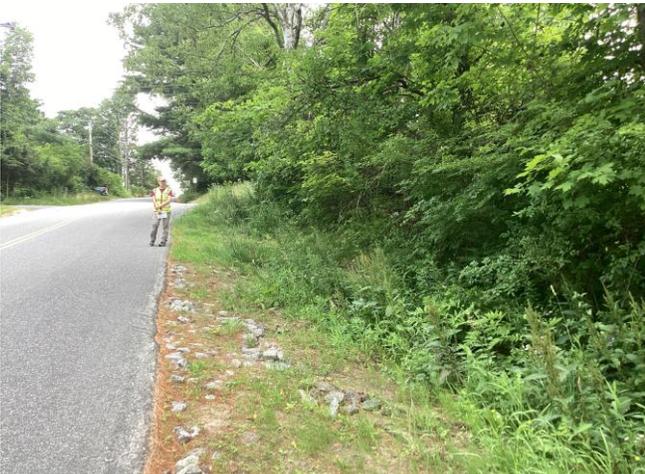
Site 108: S Pleasant Roadside	Project Type: Erosion
DESCRIPTION	
<p>Location Description: S. Pleasant St. roadside just south of Barrett Road intersection</p>	<p>Drainage Area Notes:</p>
<p>Issues/Observations: Sand washing around corner of Barrett Road and accumulating just upgradient of culvert outlet. Some riprap along road edge at culvert outfall.</p>	<p>Recommendations: Re-shape ditch, add check dams and armor with riprap. Careful of depth for digging at the lower end because of the culvert pipe. Install sediment forebay upgradient of culvert.</p>
PHOTOS/SKETCHES

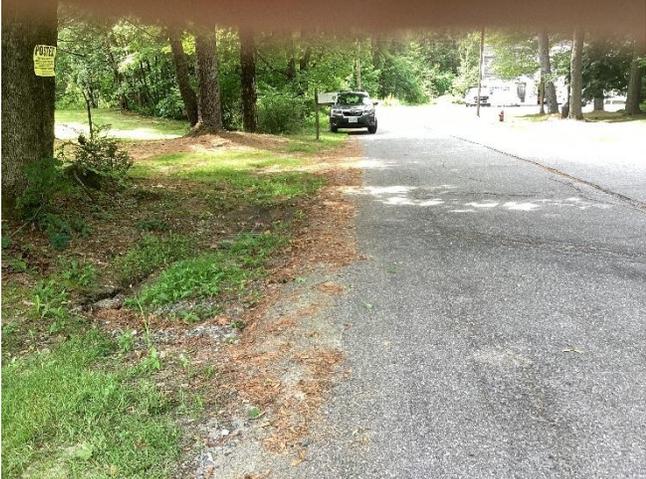
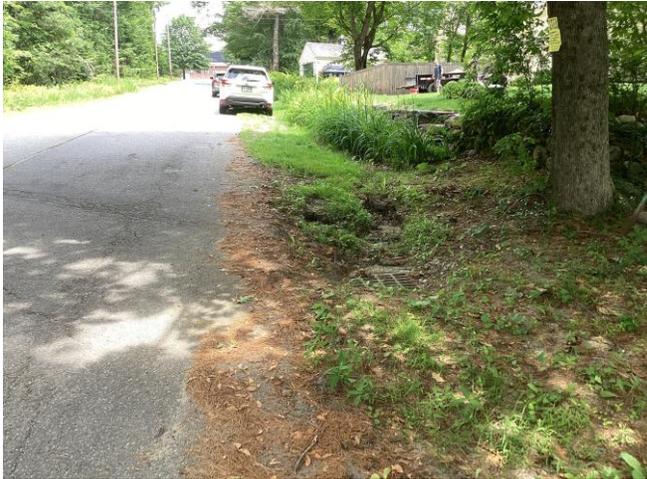
Site 109: Squires Ln	Project Type: Erosion
DESCRIPTION	
Location Description: Roadside of 39 & 51 Squires Lane	Drainage Area Notes:
Issues/Observations: Gullying at catch basins and along roadside.	Recommendations: Revegetation and sand removal.
PHOTOS/SKETCHES

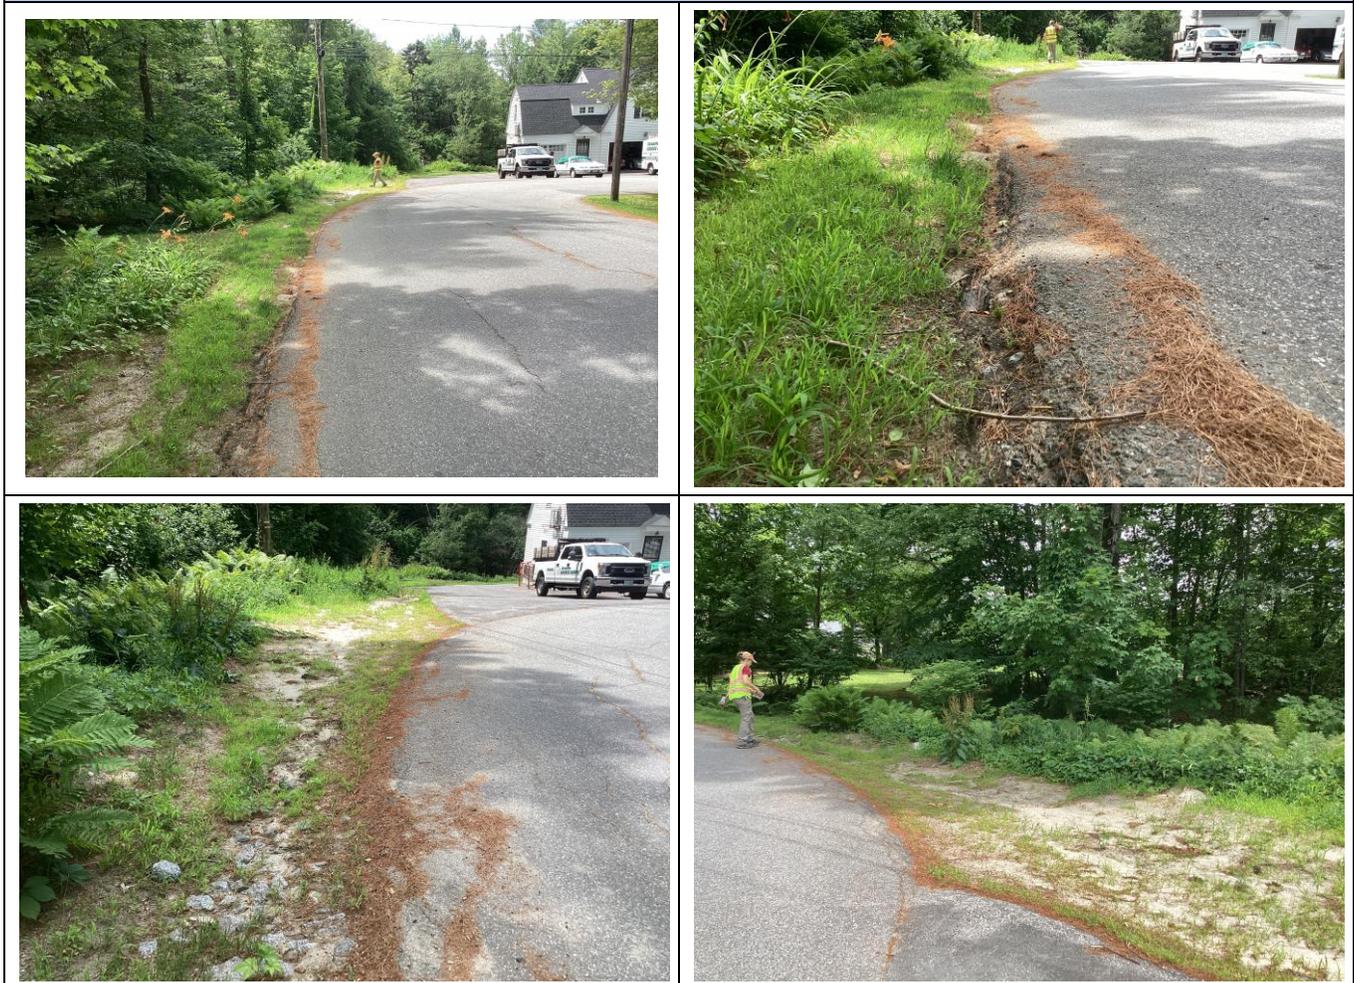
Location Description: Roadside of 51 Squires Lane (at bend)	Drainage Area Notes:
Issues/Observations: Gullying along roadside and sand accumulation. Sand accumulation area about 11.5 feet wide and 20 feet long.	Recommendations: Sand removal and revegetation.

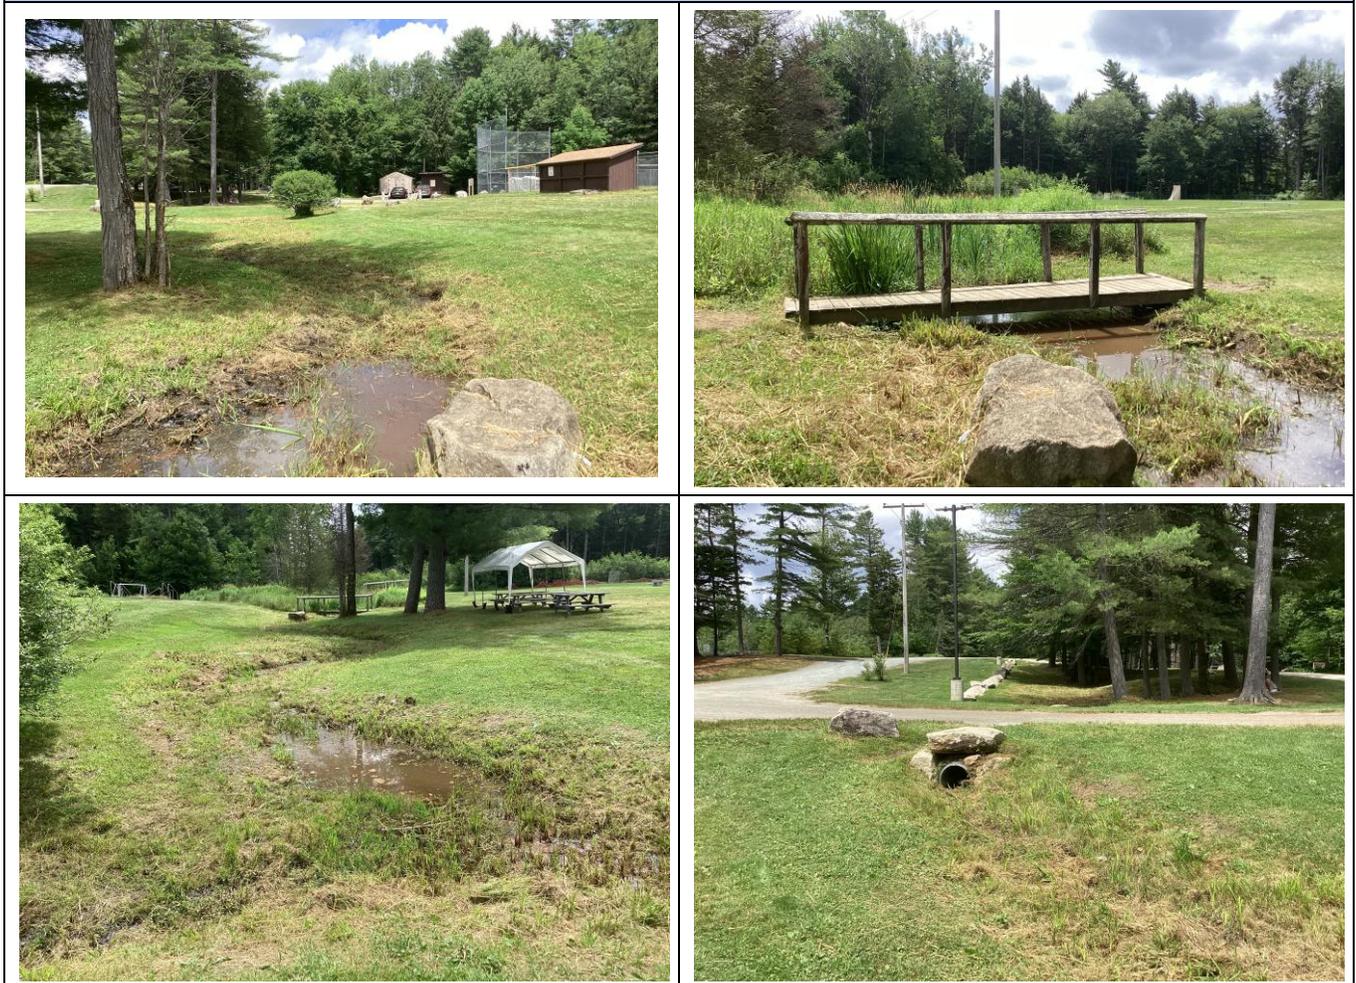
<p>Location Description: Next to lower ball field at Woodward Park</p>	<p>Drainage Area Notes:</p>
<p>Issues/Observations: Tributary coming from woods through Woodward Park. Three culvert crossings and a small bridge. Slow moving standing water. Evidence of natural oil. No buffer and all vegetation has been mowed.</p>	<p>Recommendations: Discontinue mowing to stream edge. Revegetate stream buffer.</p>

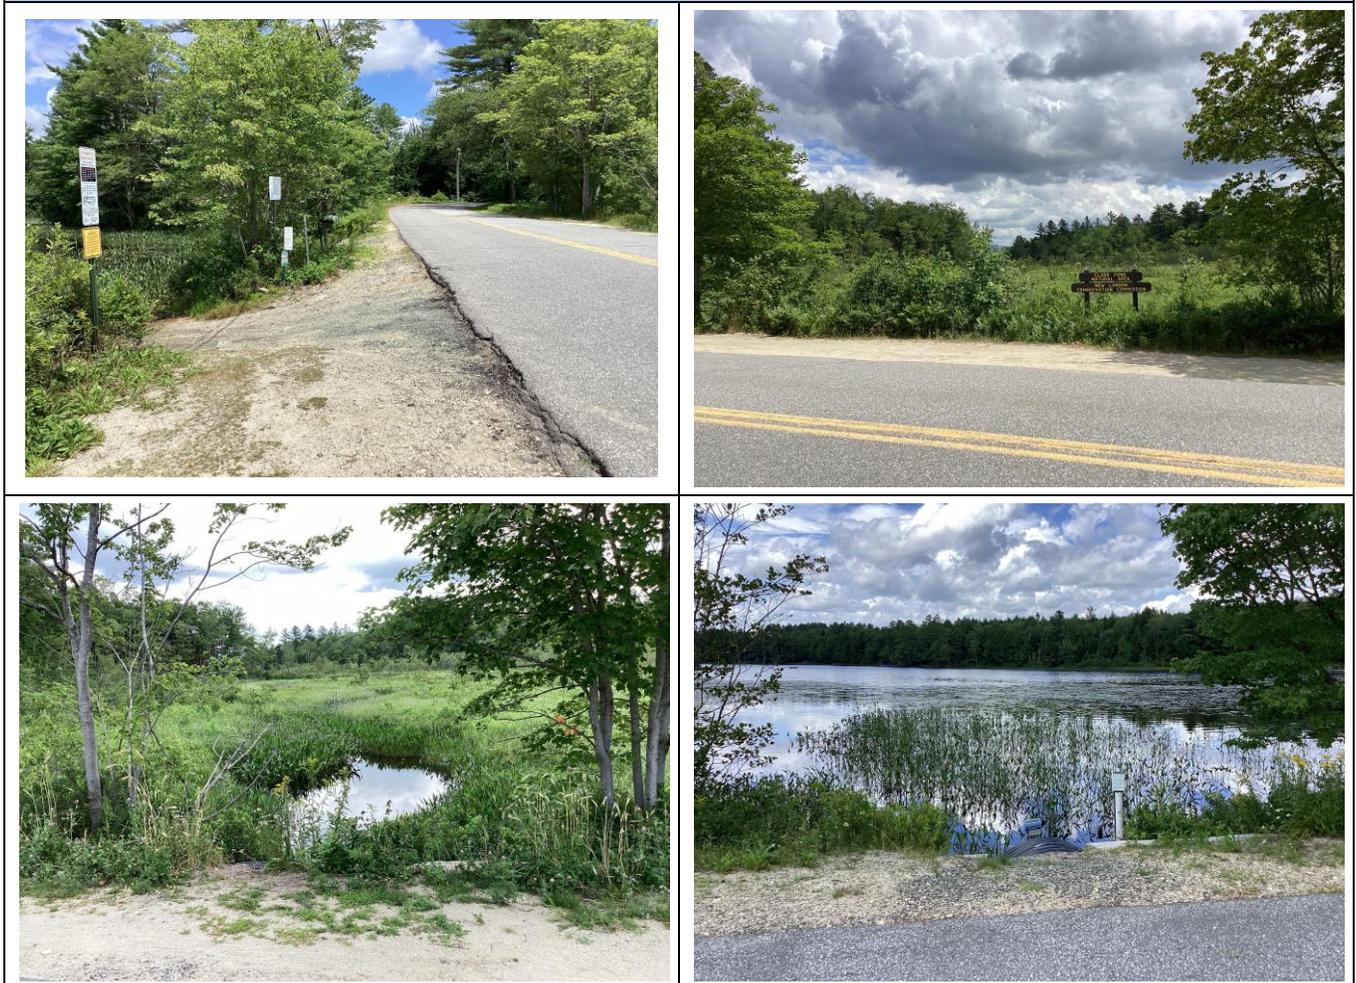
<p>Location Description: Boat ramp/access point off Bog Road to Messer Pond</p>	<p>Drainage Area Notes:</p>
<p>Issues/Observations: Unstable gravel/sand sloped access point down to pond.</p>	<p>Recommendations: Stabilize boat ramp. Install turnout upgradient of boat ramp if possible.</p>

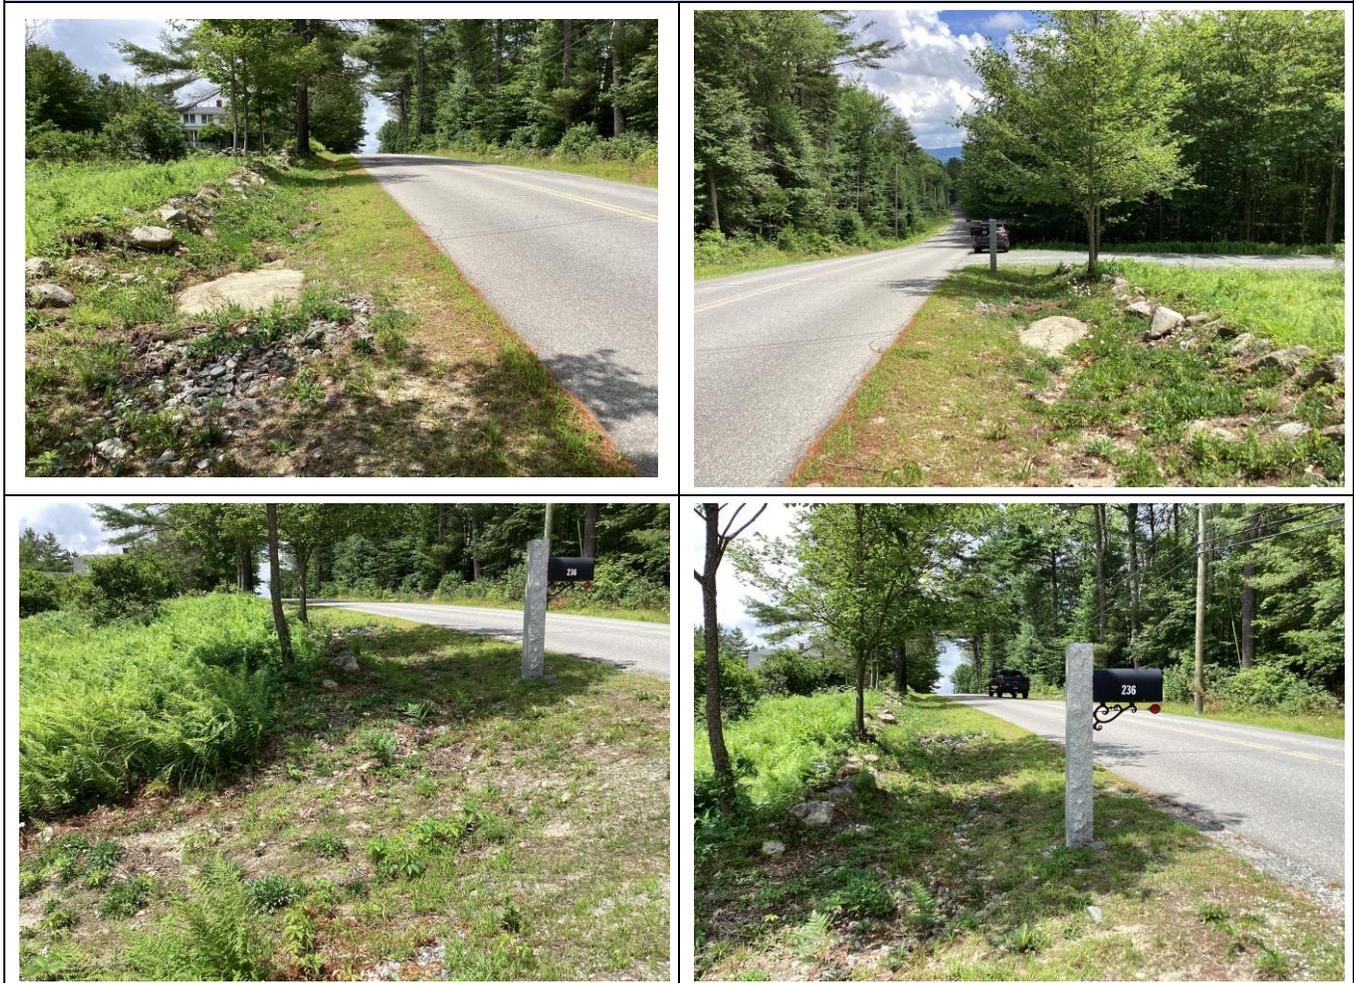
<p>Location Description: Roadside at 236 Knights Hill Road</p>	<p>Drainage Area Notes:</p>
<p>Issues/Observations: Sand accumulation and gullying. Stone check dam accumulating sand.</p>	<p>Recommendations: Clean out upgradient of check dam and add second check dam. Consider armoring ditch.</p>

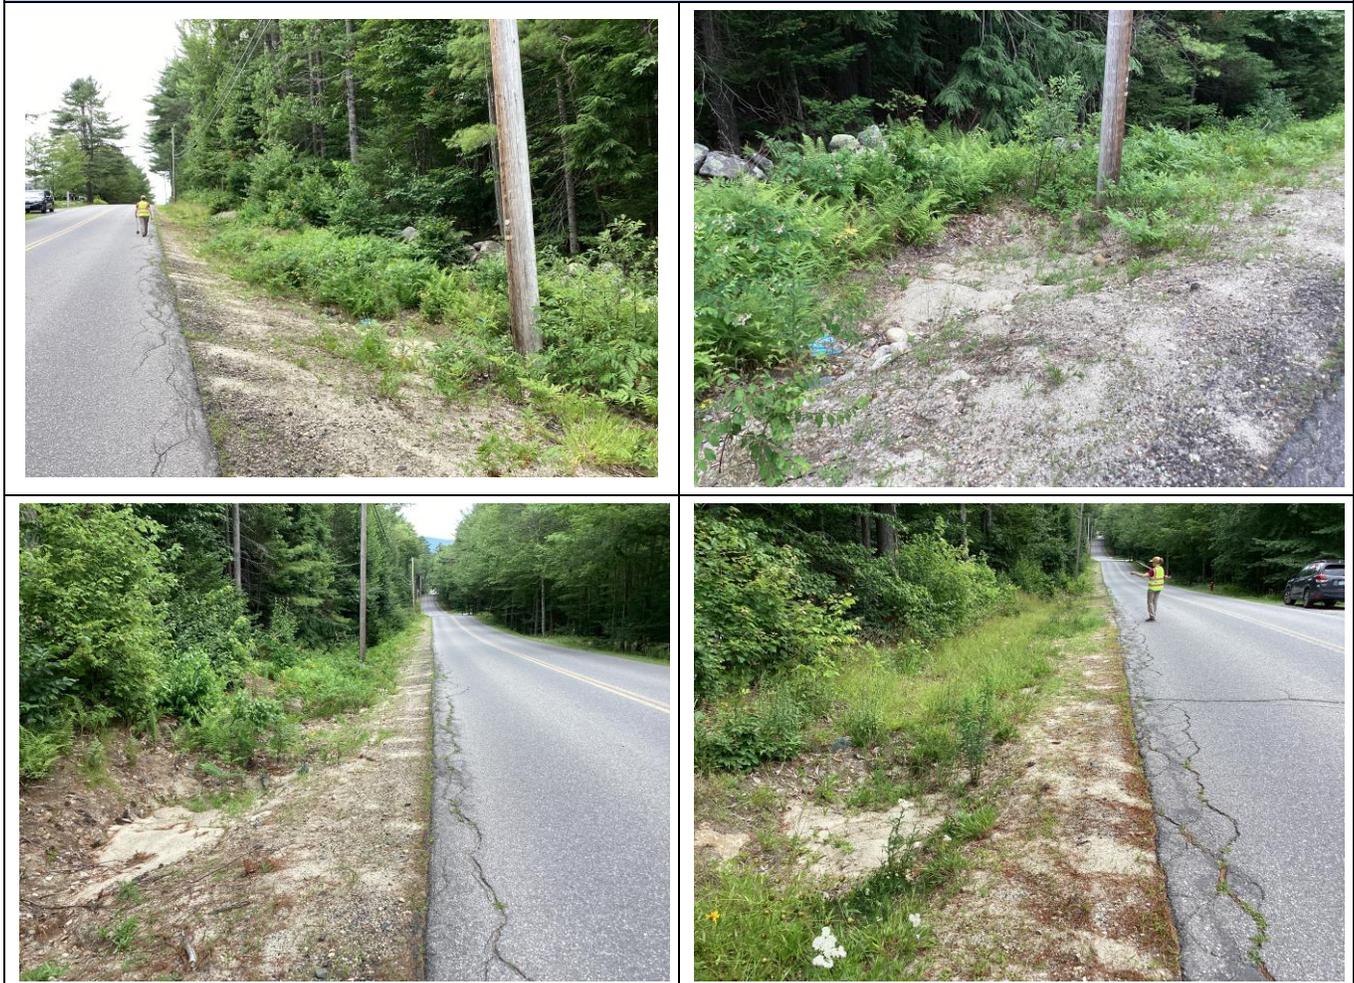
<p>Location Description: Roadside across from 236 Knights Hill Road</p>	<p>Drainage Area Notes:</p>
<p>Issues/Observations: Existing settling basins with sand accumulation. Sand along road.</p>	<p>Recommendations: Add check dams and clean out sand. Revegetate 600 feet of road (8 feet wide).</p>

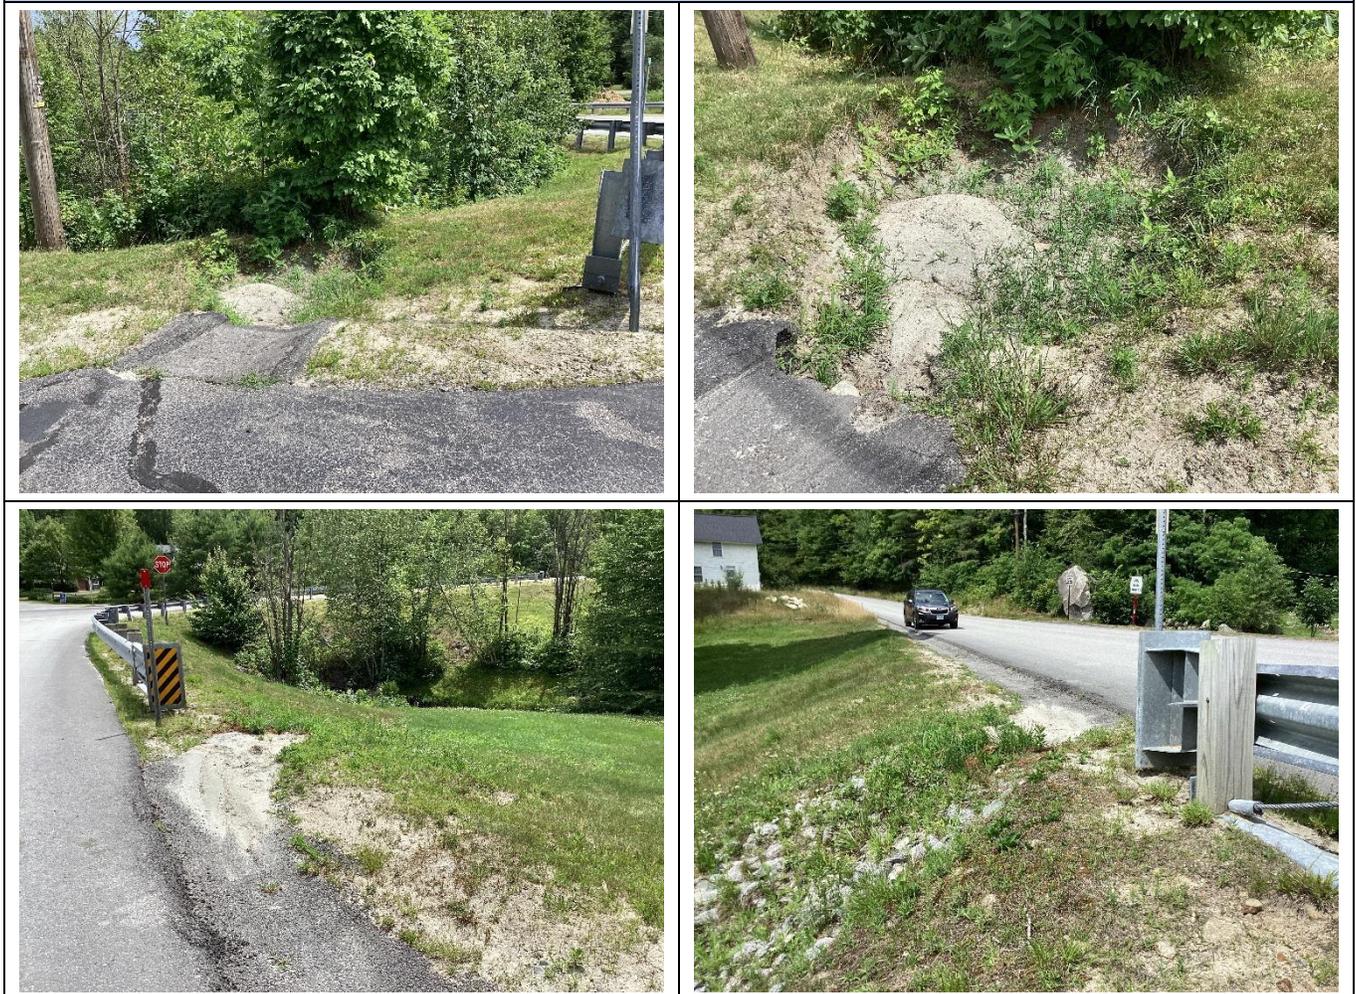
<p>Location Description: On both sides of 607 Old Main Street</p>	<p>Drainage Area Notes:</p>
<p>Issues/Observations: Sand accumulation in settling basin on the east side of the road and above check dam on the west side of the road. Paved swale along the western roadside edge.</p>	<p>Recommendations: Clean out settling basin and check dam.</p>
