WATERSHED SURVEY RESULTS MEMORANDUM

TO: Town of Sutton, NH and Kezar Lake Protective Association
FROM: Lori Kennedy, Horsley Witten Group and Christine Bunyon, FB Environmental Associates
SUBJECT: Kezar Lake Watershed Survey Results - Final
DATE: February 20, 2026

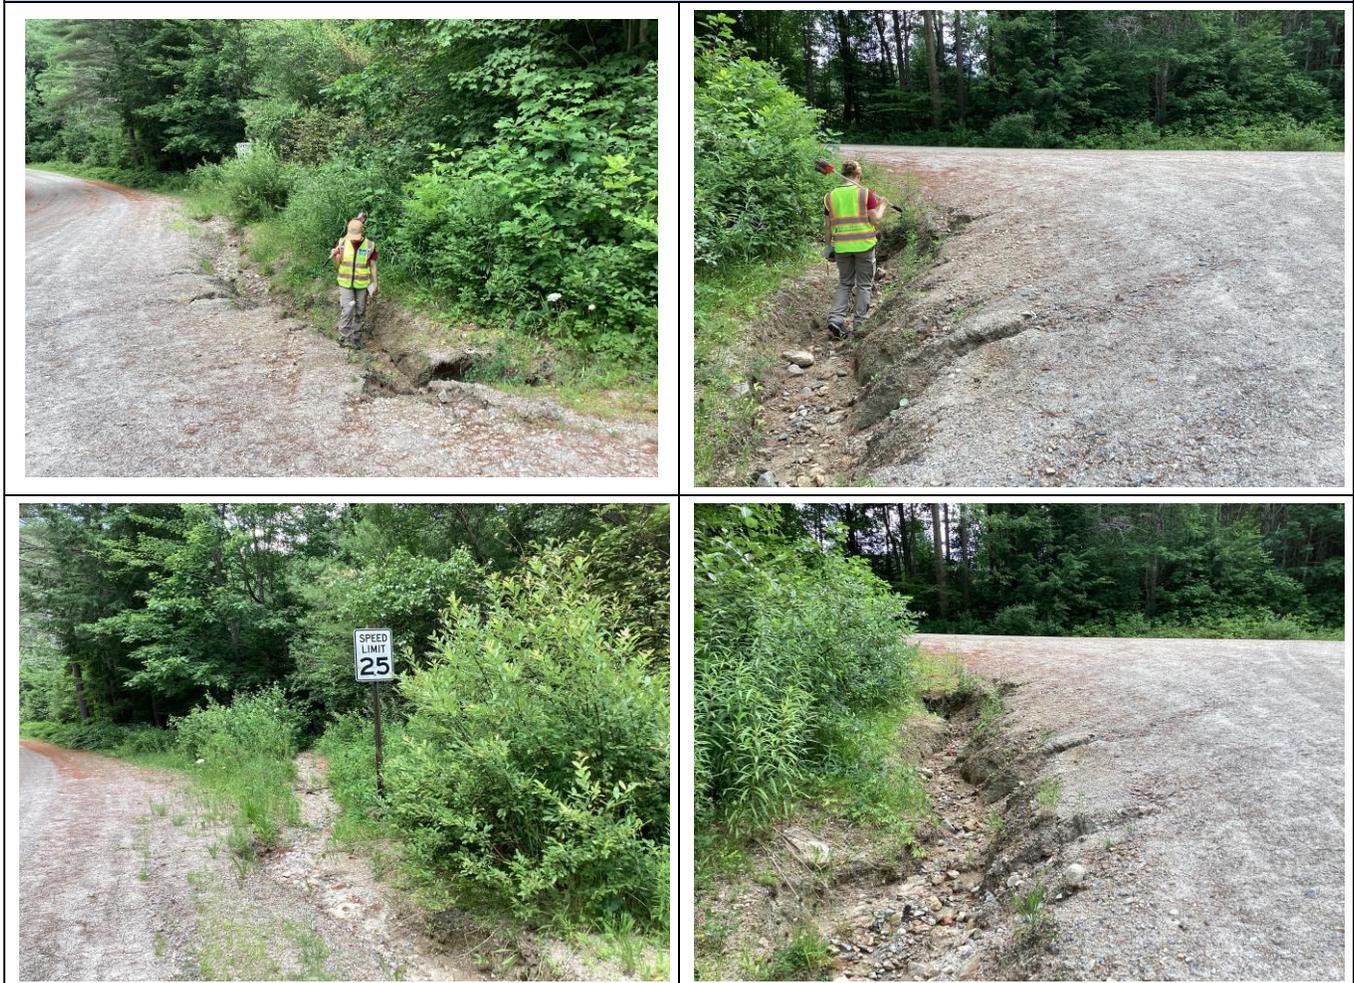
<p>Location Description: Corner of Winslow Rd and Meadowbrook Road</p>	<p>Drainage Area Notes:</p>
<p>Issues/Observations: Deep gully on Meadowbrook Road. Runoff coming from Winslow Road.</p>	<p>Recommendations: Add plunge pool and armor steep portion of the ditch. Revegetate lower flat area, add check dam.</p>

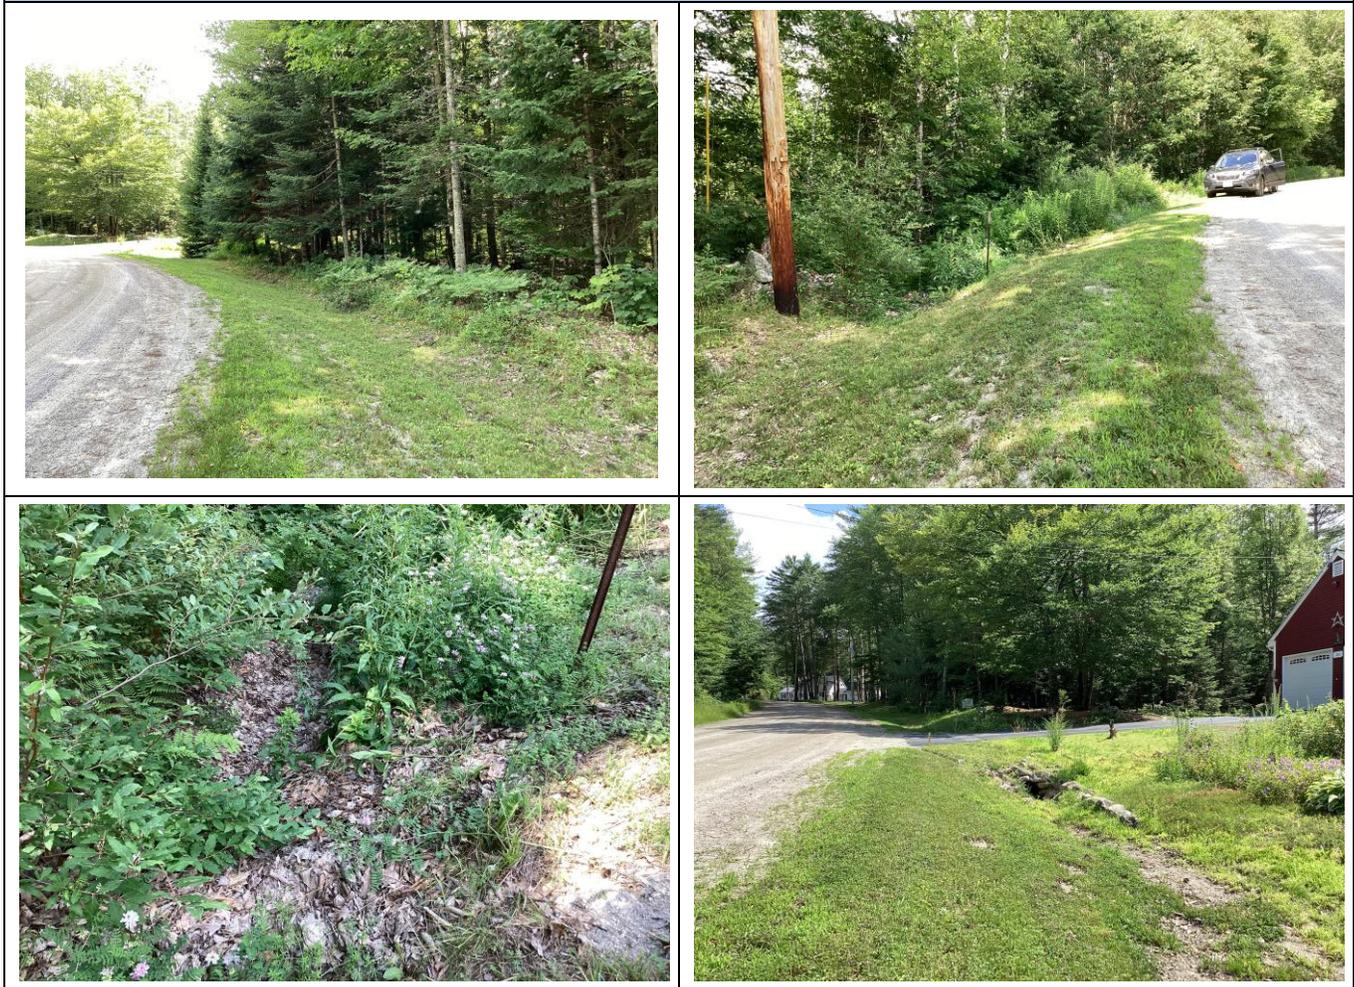
<p>Issues/Observations: Outfall of long length of roadside swale that goes under several driveway crossings. Outfall drops 6 feet then 30 feet. Large amount of leaf litter accumulation. Possibly a settling basin before 30-foot drop.</p>	<p>Recommendations: Install a roadside bioswale upgradient of existing settling basin. Clean out settling basin. Consider stepped pool system down to wetlands.</p>
---	--

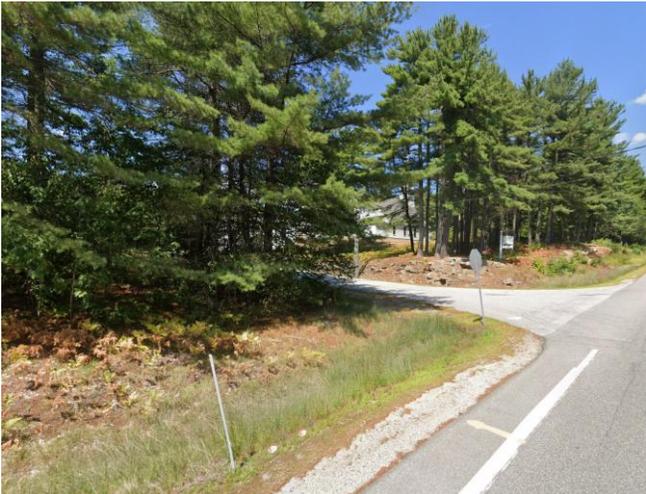
Site 118: King Hill Road	Project Type: Erosion
DESCRIPTION	
Location Description: Roadside of 130 King Hill Rd to Rowell Hill Rd	Drainage Area Notes:
Issues/Observations: Gullying along roadside.	Recommendations: Revegetate with turnouts.
PHOTOS/SKETCHES

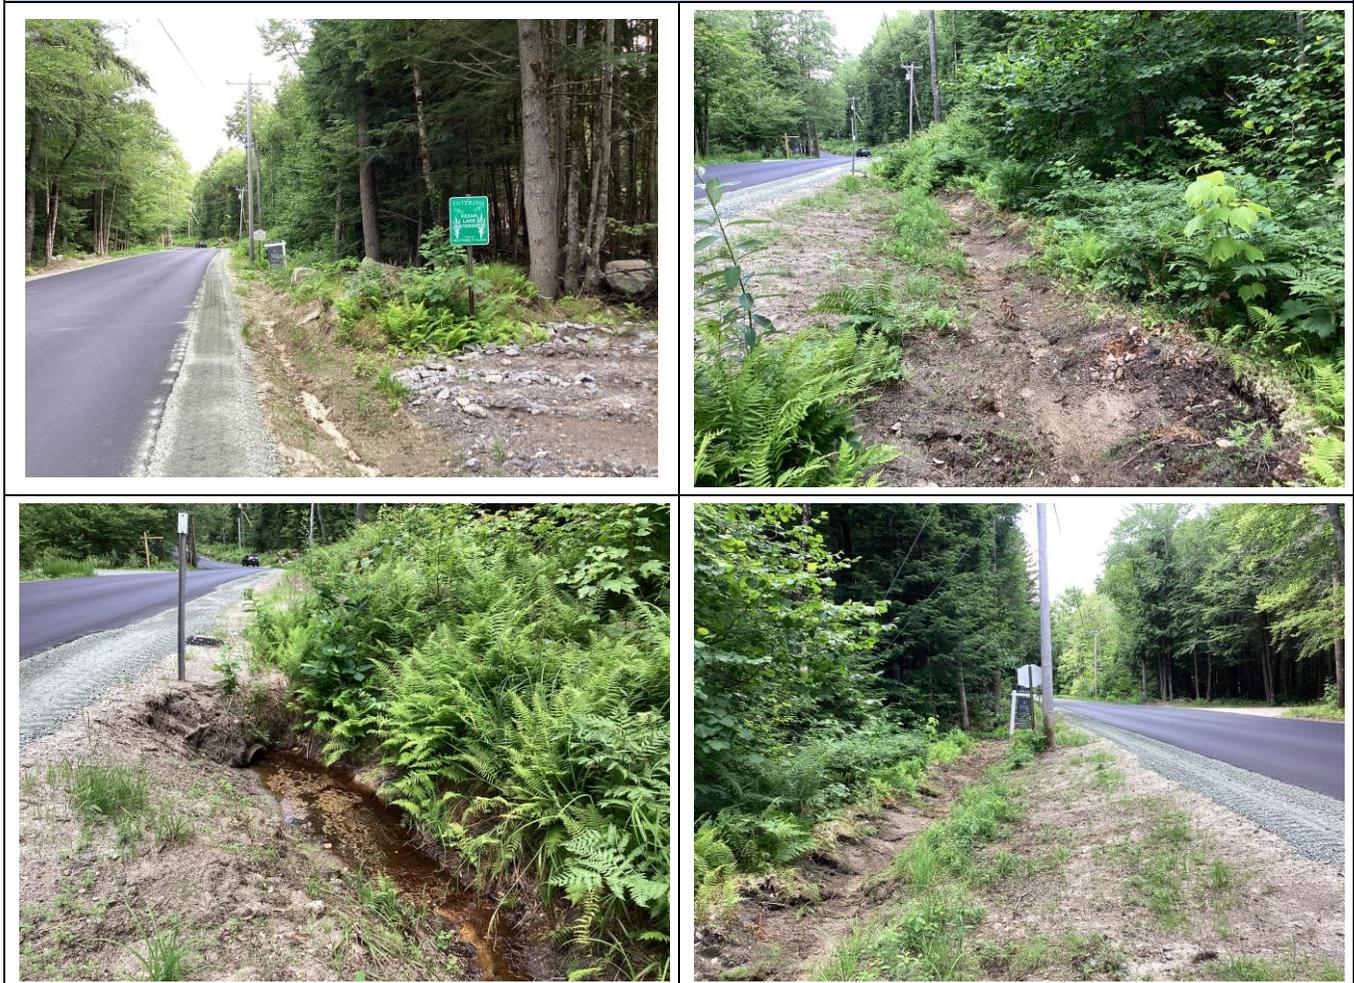
Issues/Observations: Deep ditch along road side. Freshly paved road. Appears ditch has been dug out recently. Erosion and sand accumulation starting to occur. Seed was possibly laid in ditch. Ditch crosses to other side of road in culvert at driveway crossings.	Recommendations: Armor ditch and/or revegetate.
---	---

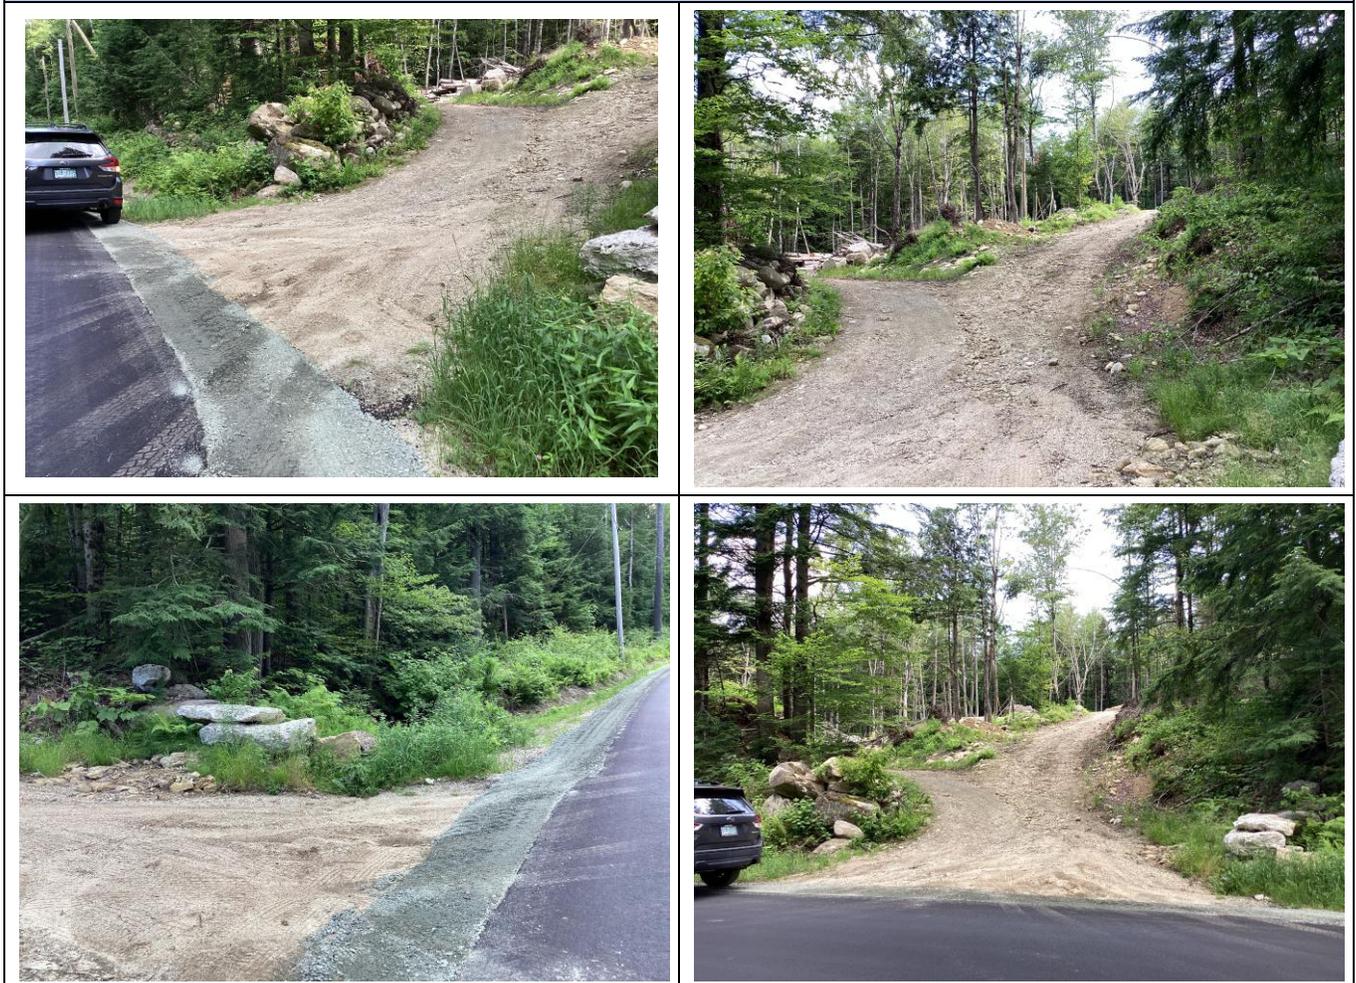
<p>Location Description: Across from 332 Hominy Pot Rd</p>	<p>Drainage Area Notes:</p>
<p>Issues/Observations: Construction site. Steep slope down to roadside ditch. Large amount of clearing.</p>	<p>Recommendations: Install erosion and sediment control practices at construction site.</p>
