KEZAR LAKE SHORELINE SURVEY | MEMORANDUM

TO: Glenn Pogust (Town of Sutton), Kyle Hubbard, and Polly Perkins (KLPA)
FROM: Christine Bunyon, FB Environmental Associates (FBE)
SUBJECT: Kezar Lake Shoreline Survey Results - PUBLIC
DATE: January 16, 2026

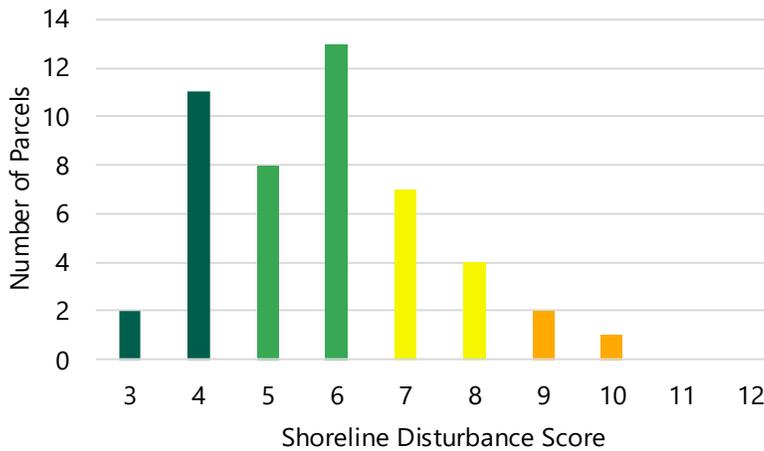
Figure 1. Histogram showing the number of parcels by Shoreline Disturbance Score. The possible range of Shoreline Disturbance Scores is 3-12. A score of 7 or above indicates shoreline conditions that may be detrimental to lake water quality

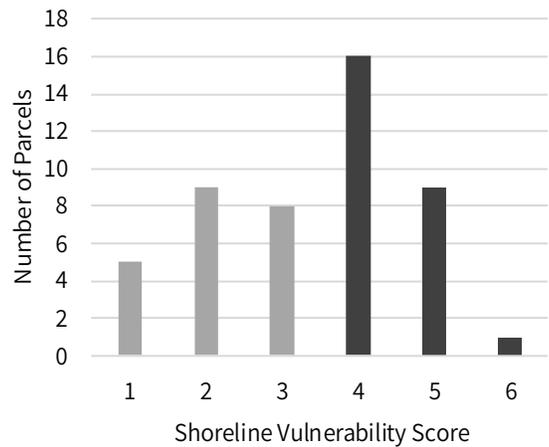
Figure 2. Histogram showing the number of parcels by Shoreline Vulnerability Score. The possible range of Shoreline Vulnerability Scores is 1-6. A score of 4 or above indicate a parcel may be more prone to erosion issues whether or not adequate buffers and soil coverage are present.
