# Community Watershed Analysis Final Report

### Kezar Lake

Colby-Sawyer College

Community-Based Project Class of 2021-2022

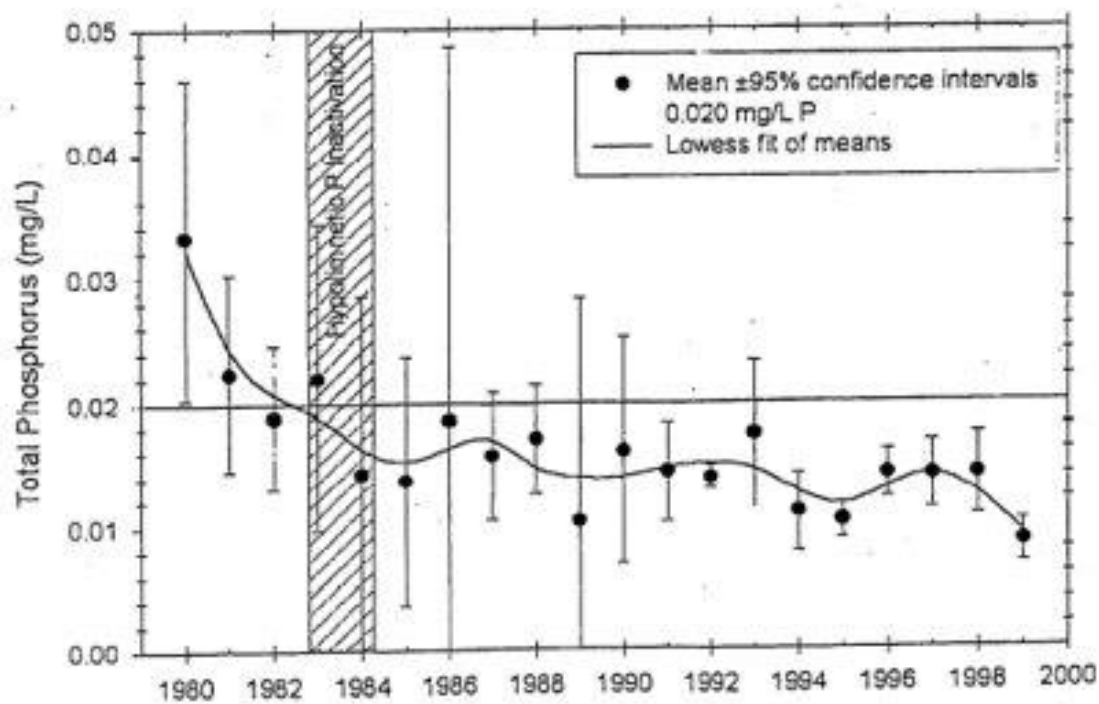
**Figure 1.** Total Phosphorus (mg/L) mean levels at Kezar Lake from 1980 to 2000. (Connor and Smagula, 2000)

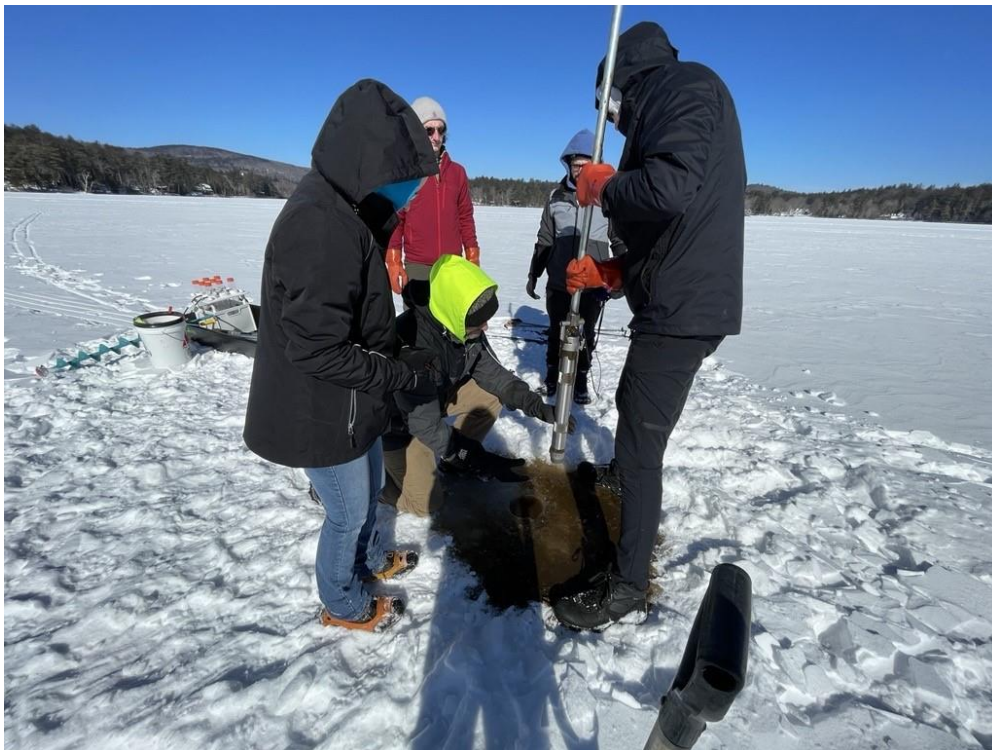
**Image 2.** The CBP is pictured here taking sediment core samples from Kezar Lake using their new sediment corer.

During the winter, the CBP collected samples in plastic sediment core tubes at numerous locations surrounding the Deep Site for a total of eight samples- one being a testing sample. Using a series of connected pipes, the CBP was able to lower the sediment core to the bottom of the lake and take a core sample to store and freeze in plastic tubing at a later date. In the image below, the CBP had just pulled the core from the bottom and were capping the plastic tubing for storage.

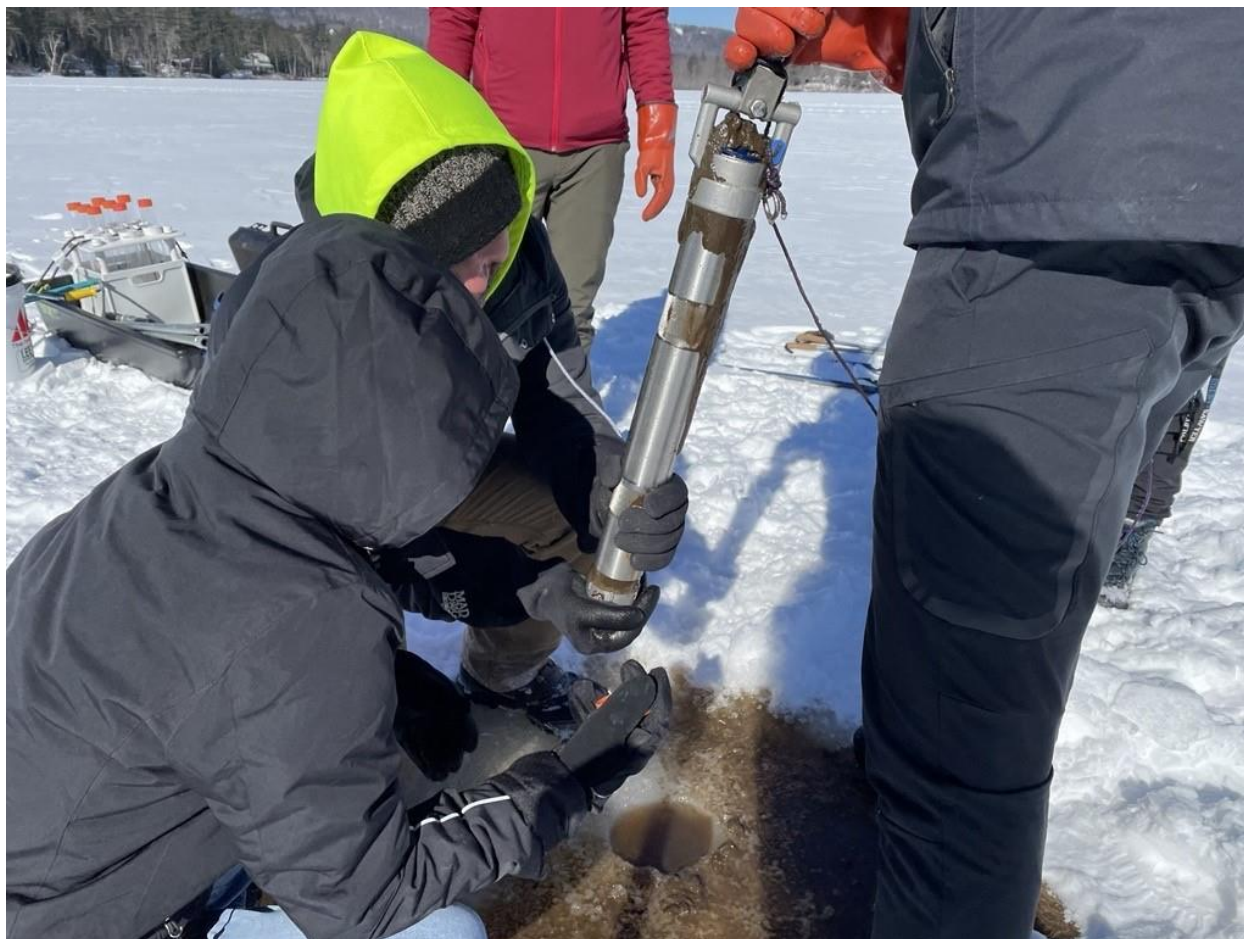
**Image 3.** The CBP is attempting to cap the plastic tubing which stores the core sample.

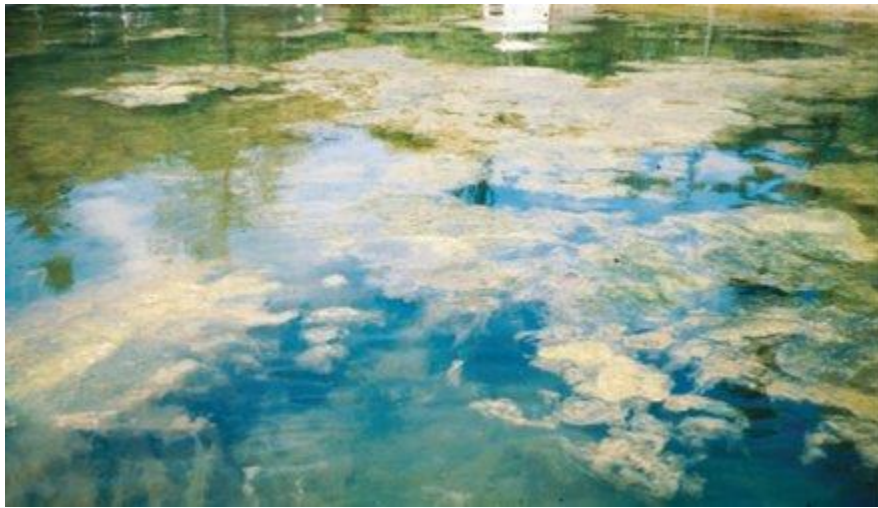
***Image 5.*** Algal blooms in Kezar Lake from 1963 as a result of intense phosphorus loading prior to the alum treatment (Marcoux & Beck, 2017).

*Image 5.* Algal blooms in Kezar Lake from 1963 as a result of intense phosphorus loading prior to the alum treatment (*Beck & Marcoux, United States Environmental Protection Agency*).

2013). Algal blooms have proved to be a prominent issue for many fresh and saltwater systems across the United States in recent years, including Kezar Lake from the mid 1960's to 1984 when the Kezar Lake Restoration Program was put into effect. The CBP is examining the chlorophyll-a content of the Kezar Lake Deep Site, located above its deepest point of approximately 25 feet. Below are *Image 5* and *Image 6* showing the before and after appearance of Kezar Lake.

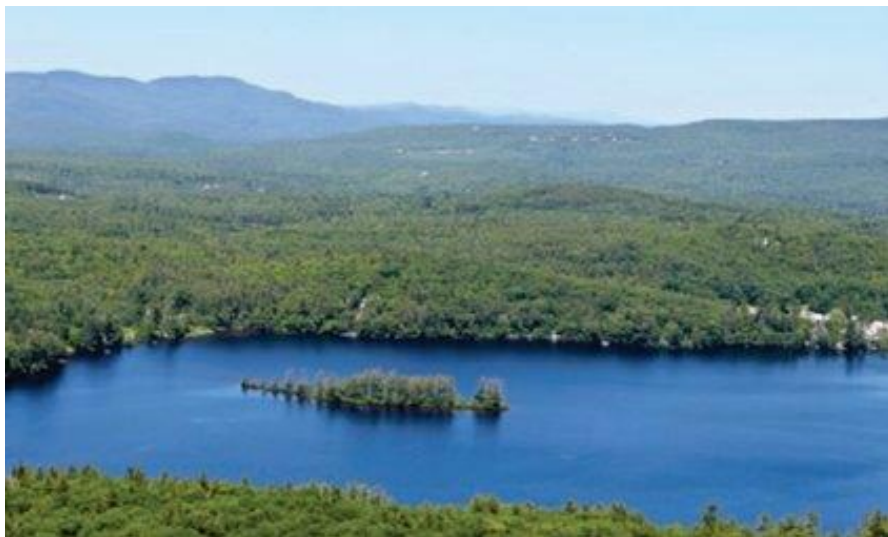
***Image 6.*** Kezar Lake years after the alum treatment (Marcoux & Beck, 2017).

*Image 6.* Kezar Lake years after the alum treatment (*Marcoux & Beck, 2017*).

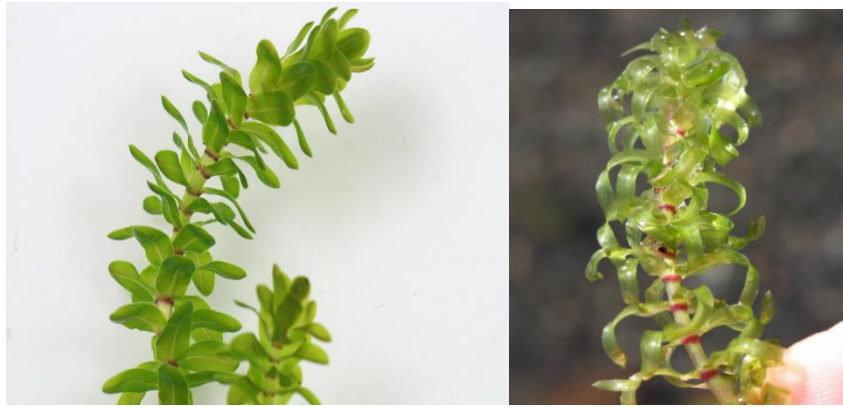
**Images 8 & 9.** A closeup photo of *E. canadensis* (left) and *E. nuttallii* (right).

*Image 8.* A closeup photo of *E. canadensis*.

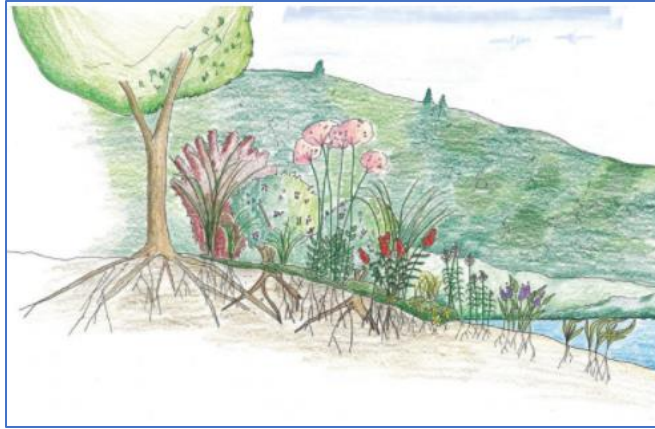
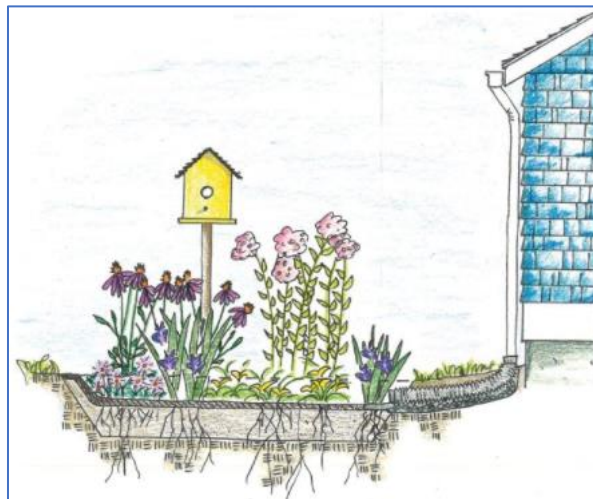
***Images 11 & 12.*** Vegetative Buffer & Rain Garden illustrations by Jillian McCarthy
