Kezar Lake

*From Good to Bad, and Back Again
A 70+ Year Retrospective*

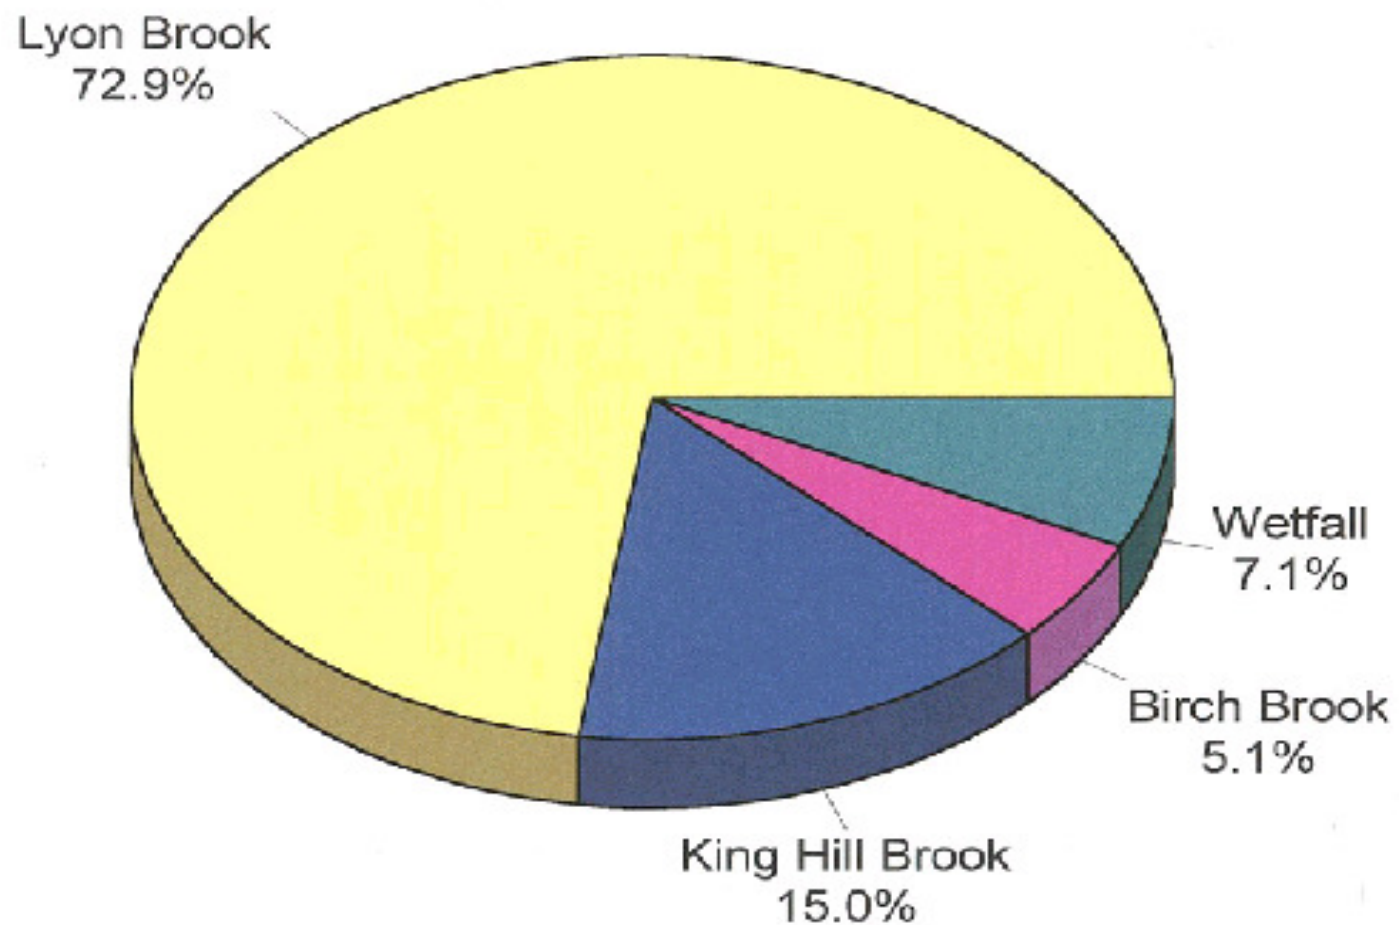
Figure - VI-1: Total Inflow and Wetfall Contributions to Kezar Lake for 1990-91 Phase III

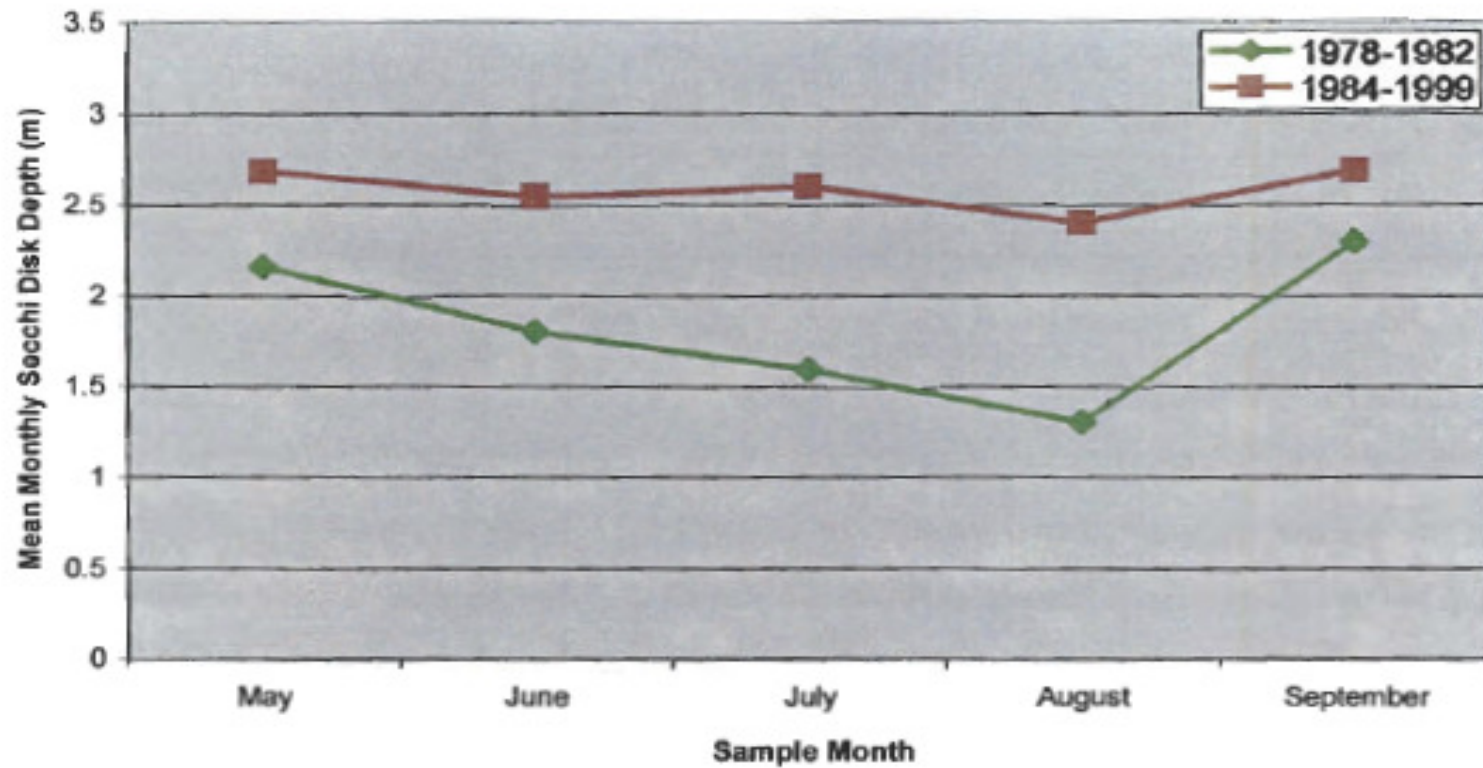
Figure IV-6 A comparison of pre- and post treatment mean monthly transparency (m) in Kezar Lake, North Sutton

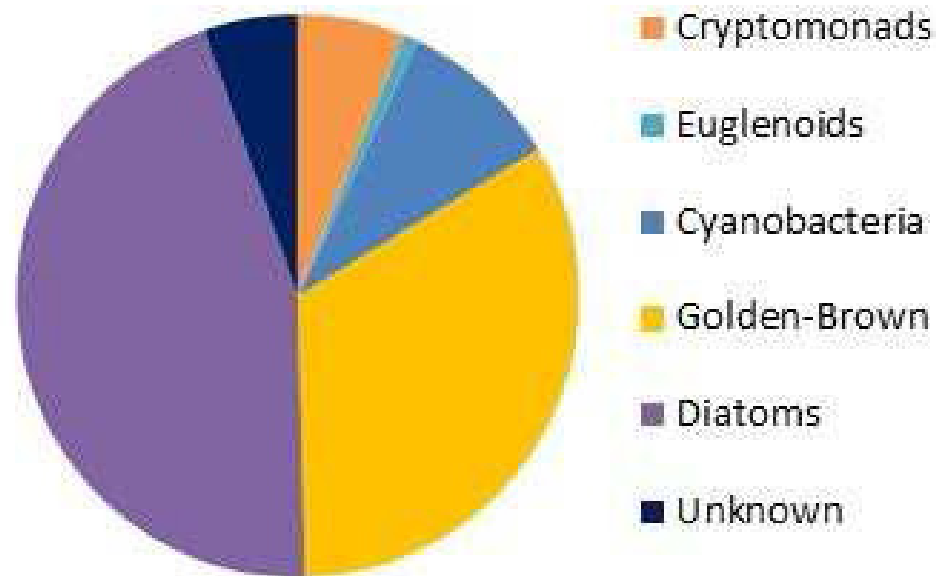
**Kezar Lake, Algal Population
September 2015**

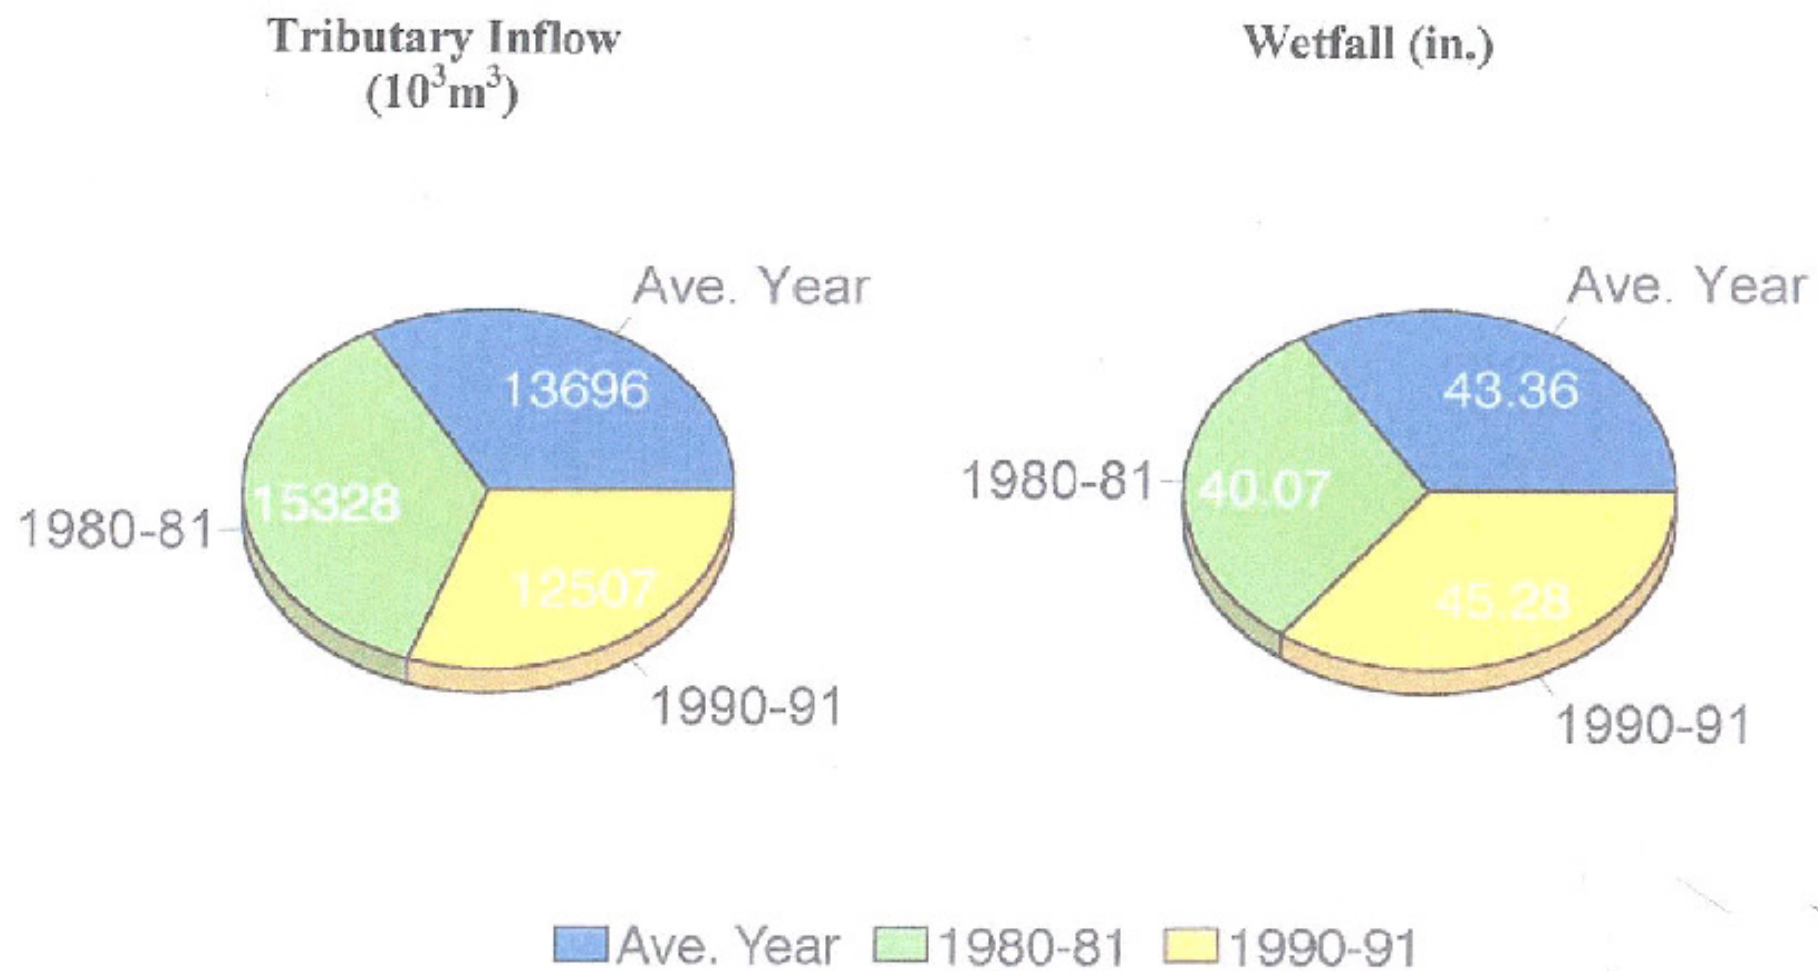
Figure VI-2 A Comparison of Annual Tributary Inflow and Wetfall for Two Budget Years and Average Year
