WATERSHED SURVEY RESULTS MEMORANDUM

TO: Town of Sutton, NH and Kezar Lake Protective Association
FROM: Lori Kennedy, Horsley Witten Group and Christine Bunyon, FB Environmental Associates
SUBJECT: Kezar Lake Watershed Survey Results - Final
DATE: February 20, 2026

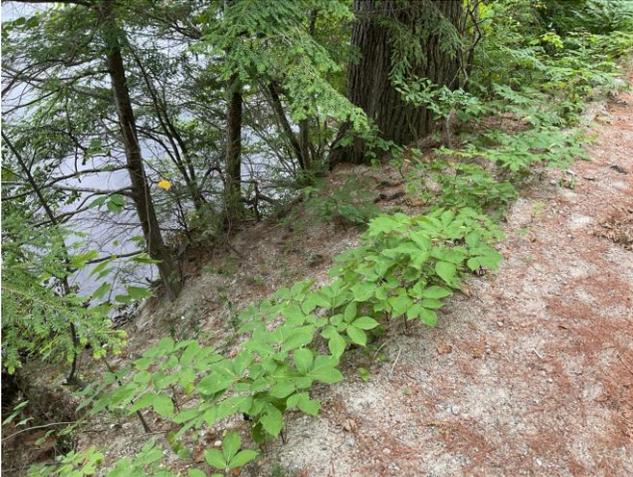
Site 12: Unpaved part of Penacook Rd	Project Type: Erosion, Buffer
DESCRIPTION	
<p>Location Description: Transition from paved to gravel road near 101 Penacook Rd</p>	<p>Drainage Area Notes:</p>
<p>Issues/Observations: Gravel road is 18 ft wide; vehicles primarily use 13 ft drive lane and slow down to pass approaching vehicles. Heavily used by pedestrians. Narrow, steep shoreline buffer with intermittent gullies eroding down to lake. Shoreline vegetation impacted by winter sand and salt.</p>	<p>Recommendations: Improve drainage, stabilize erosion, and restore shoreline buffer along waterfront stretch of gravel road. Expand/maintain ditches on uphill (west) side; add forebays and armoring at cross culverts. Berm on waterfront (east) side, with stabilized outflow at low points. Consider narrowing street to single travel lane with wider pull-off/passing areas, to create space for pedestrian zone and wider shoreline buffer.</p>

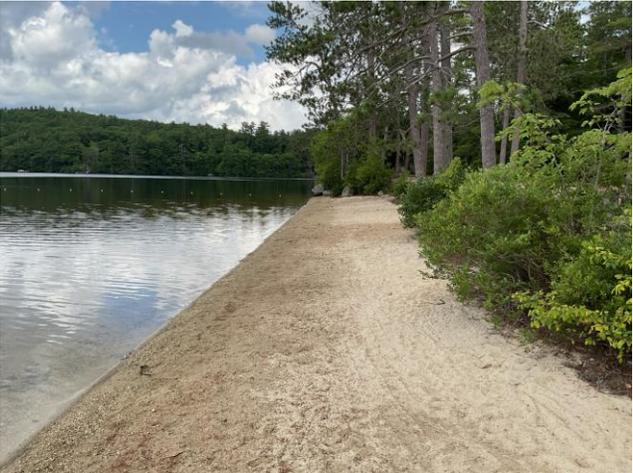
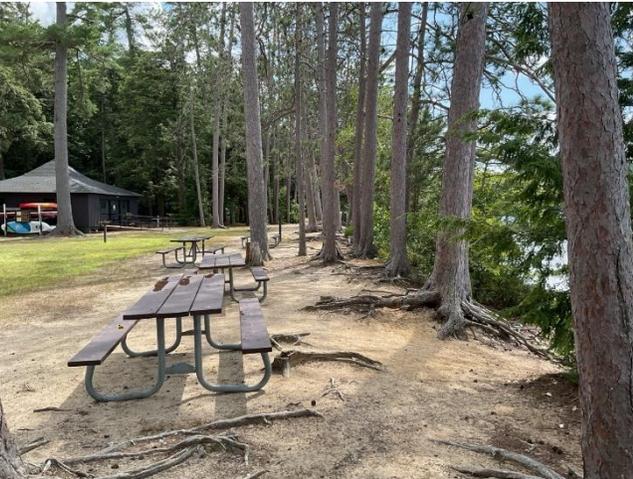
Site 17: Wadleigh State Park beach	Project Type: Erosion, Buffer
DESCRIPTION	
<p>Location Description: Entire beach</p>	<p>Drainage Area Notes:</p>
<p>Issues/Observations: Long stretch of sandy beach below line of pine trees, path, and picnic areas. Erosion around exposed tree roots. Eroding informal access points to beach at breaks in vegetation. Beach sand is regularly dragged/combed but not replenished. Retaining wall in one section (see photo). Lake level rises to picnic tables and path after big storms. Erosion is accelerating.</p>	<p>Recommendations: Construct a retaining wall below tree line (similar to existing) and restore vegetated buffer above beach. Plant a more diverse forest mix in areas of open canopy or where dead, diseased, or hazard trees will be removed (existing red pines and hemlocks are threatened by disease). Formalize steps and paths to parking lot and beach to discourage unauthorized paths, which can cause erosion.</p>

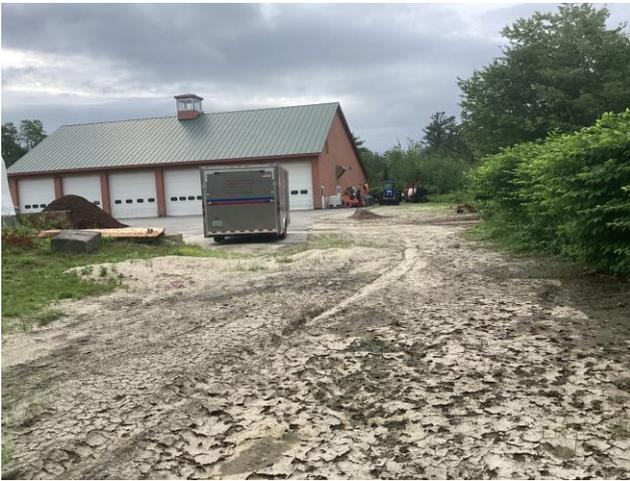
Issues/Observations:
Existing shallow stormwater pond with fabric and stone below ground for infiltration. Very rarely will water rise up and overflow over berm. This area is also used for snow storage.

Recommendations:
Replace existing shallow stormwater pond with bioretention area.

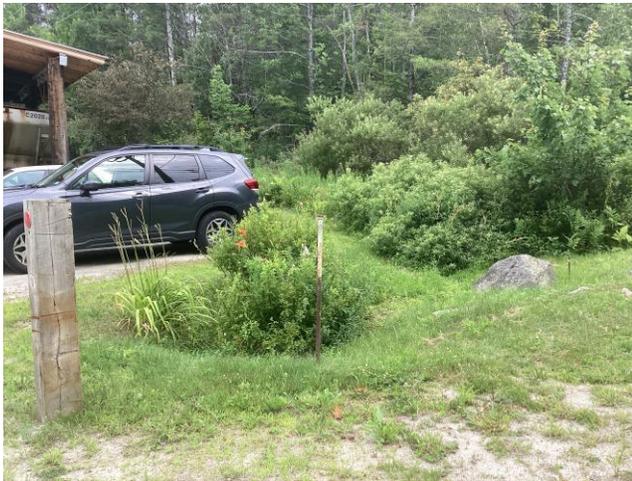
<p>Issues/Observations: Existing plastic culvert is starting to collapse, lots of water flows down to culvert. Water overtops culvert and flows down road. Armored ditch will fill up to road in large storm.</p>	<p>Recommendations: Culvert replacement. Consider upsizing culvert. DPW is considering removing this entrance in redevelopment project. If this is the case, consider a larger settling basin in location of entrance.</p>
--	---

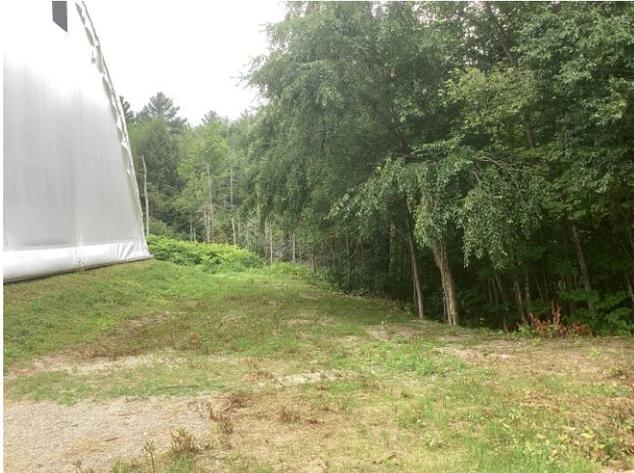
Site 104: New London DPW behind salt shed	Project Type: Buffer
DESCRIPTION	
Location Description: Behind salt shed along forest/wetland edge	Drainage Area Notes:
Issues/Observations: Some sand washing over edge.	Recommendations: Extend berm around corner and behind shed up to retention pond. Revegetate behind shed.
PHOTOS/SKETCHES

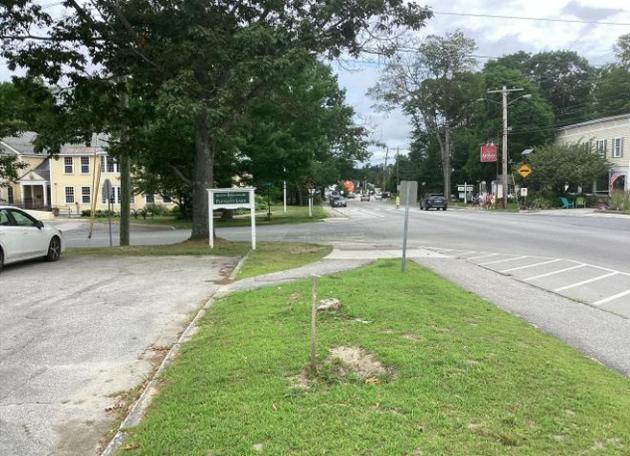
Site 106: Municipal lot	Project Type: Stormwater
DESCRIPTION	
<p>Location Description: Municipal lot at intersection of S. Pleasant St and Main St</p>	<p>Drainage Area Notes: Parking lot.</p>
<p>Issues/Observations: Large paved parking lot with no stormwater treatment. Sediment accumulation in northwest corner. Damaged pavement and sediment accumulation at entrance from standing water due to poor drainage.</p>	<p>Recommendations: Bioretention in northwest corner. Consider re-grading and striping parking lot. Regrade entrance of parking lot to keep road runoff in road. Consider landscape/bioswale island and second stormwater practice in southeast corner.</p>
PHOTOS/SKETCHES

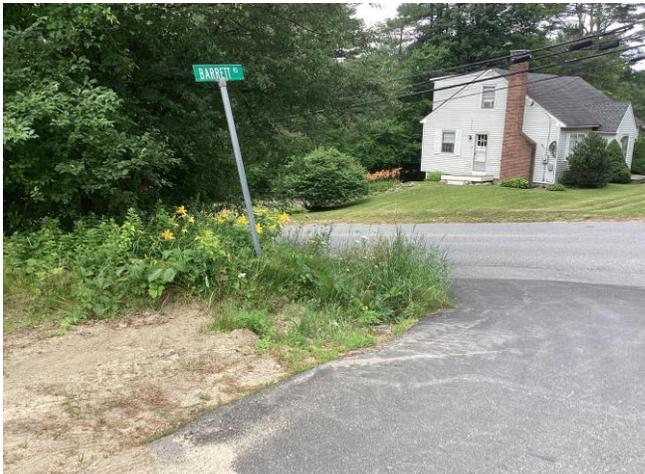
Site 108: S Pleasant Roadside	Project Type: Erosion
DESCRIPTION	
<p>Location Description: S. Pleasant St. roadside just south of Barrett Road intersection</p>	<p>Drainage Area Notes:</p>
<p>Issues/Observations: Sand washing around corner of Barrett Road and accumulating just upgradient of culvert outlet. Some riprap along road edge at culvert outfall.</p>	<p>Recommendations: Re-shape ditch, add check dams and armor with riprap. Careful of depth for digging at the lower end because of the culvert pipe. Install sediment forebay upgradient of culvert.</p>
PHOTOS/SKETCHES

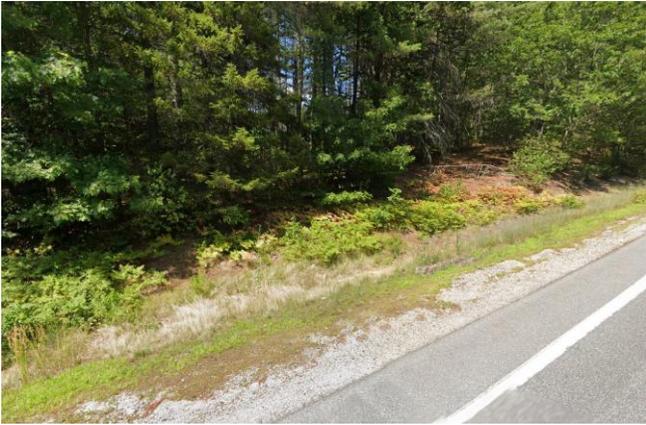
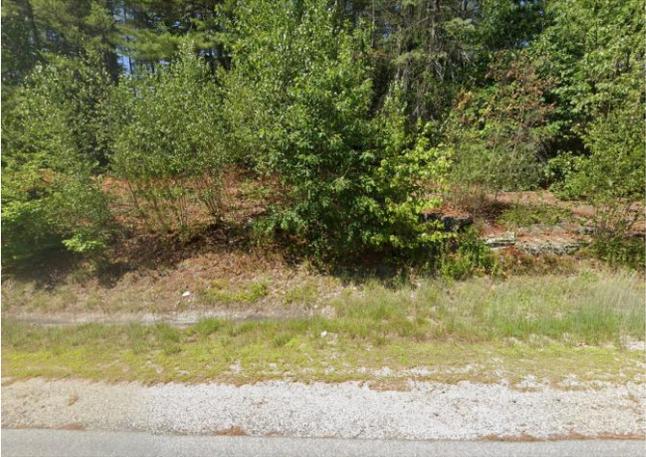
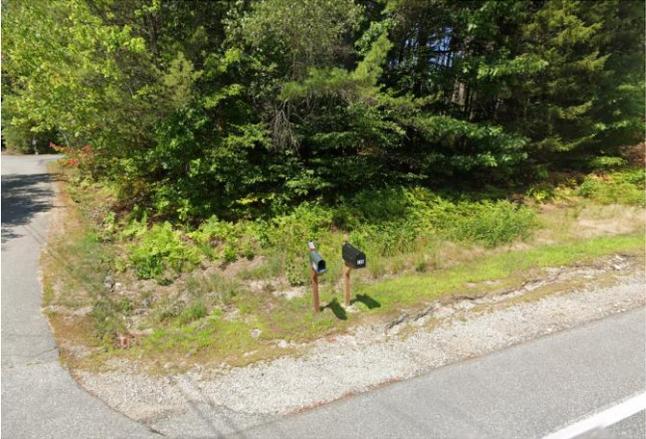
Site 118: King Hill Road	Project Type: Erosion
DESCRIPTION	
Location Description: Roadside of 130 King Hill Rd to Rowell Hill Rd	Drainage Area Notes:
Issues/Observations: Gullying along roadside.	Recommendations: Revegetate with turnouts.
PHOTOS/SKETCHES
