KEZAR LAKE SHORELINE SURVEY | MEMORANDUM

TO: Glenn Pogust (Town of Sutton), Kyle Hubbard, and Polly Perkins (KLPA)
FROM: Christine Bunyon, FB Environmental Associates (FBE)
SUBJECT: Kezar Lake Shoreline Survey Results - PUBLIC
DATE: January 16, 2026

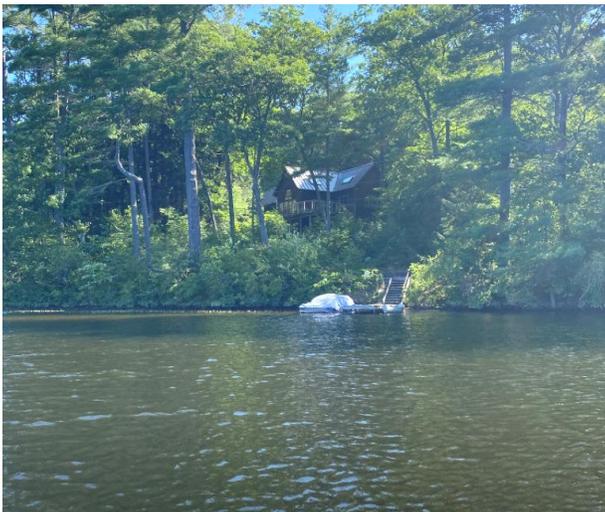
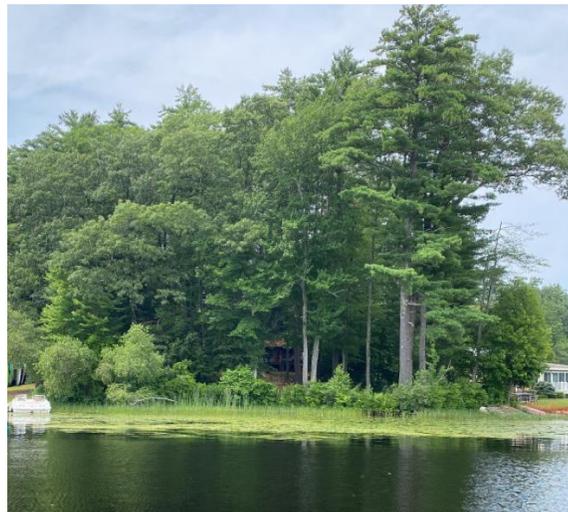
Examples of adequate vegetated shoreline buffers:

Examples of shoreline properties with great vegetated buffers consisting of multi-story canopy (trees and shrubs) and no exposed soil). Photo not from Kezar Lake for homeowner privacy.
